Santa Barbara City College

SBCC Campus & Building Assessments Report

April 2016

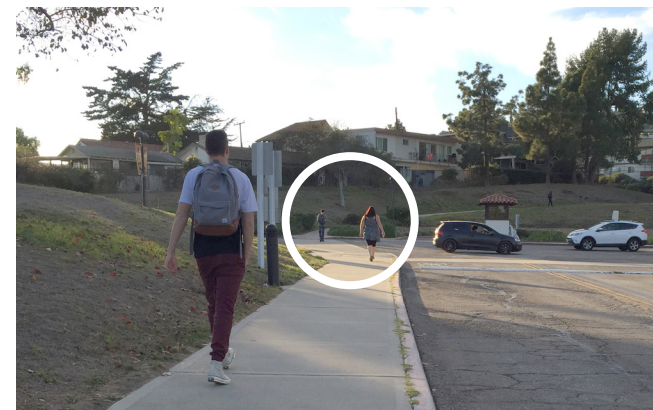
West Campus Entrance, desire line
 • Students walk dangerously in roadway.

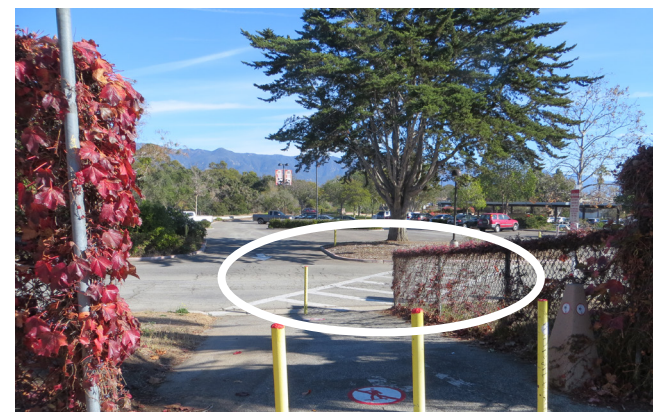
West Campus Entrance, sidewalk + crosswalk
 • Vehicles are not required to stop posing a hazard to pedestrians.

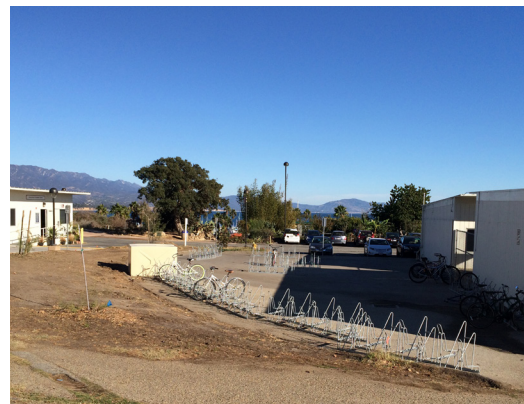
Tertiary pedestrian path, East Campus

- Tertiary paths are often in poor condition, and due to slope and materials, are noncompliant.

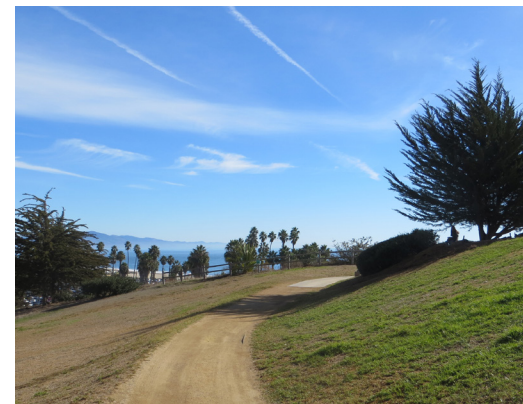
Garden path, Great Meadow

- Garden paths often lack proper drainage and are noncompliant.

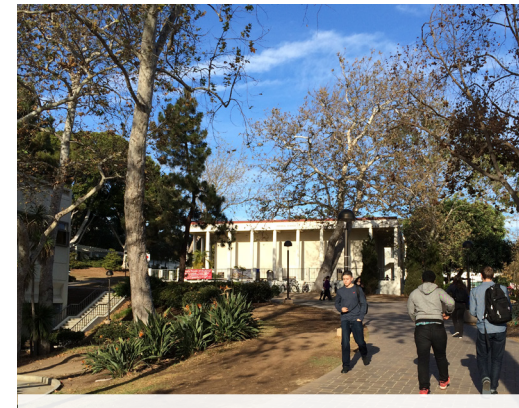
Primary pedestrian path, East Campus

- Paths along the main axis are often not wide enough, leading to adjacent landscape damage.

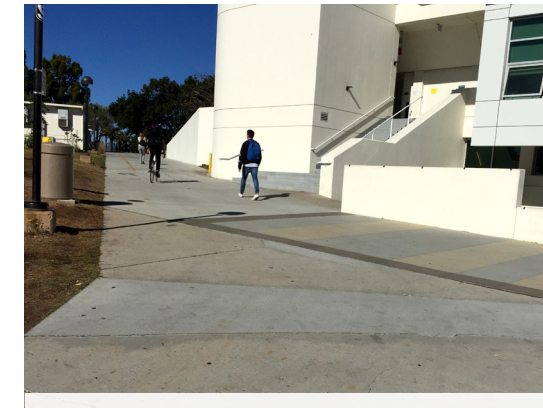
Secondary pedestrian path, East Campus

- Inconsistent paving material does not promote a clear hierarchy of pathways.

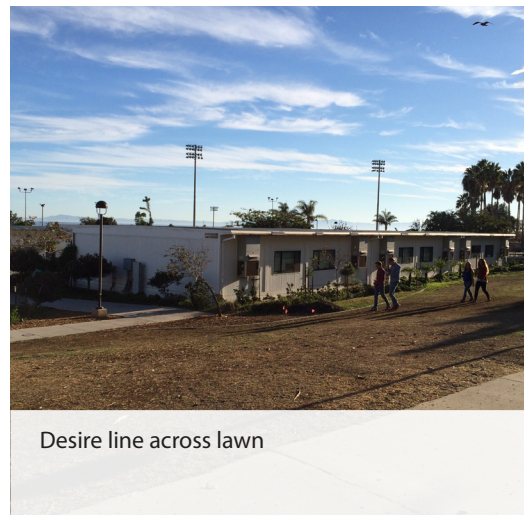
Desire line across lawn

- Students cut across the lawn in an area that lacks defined paths.

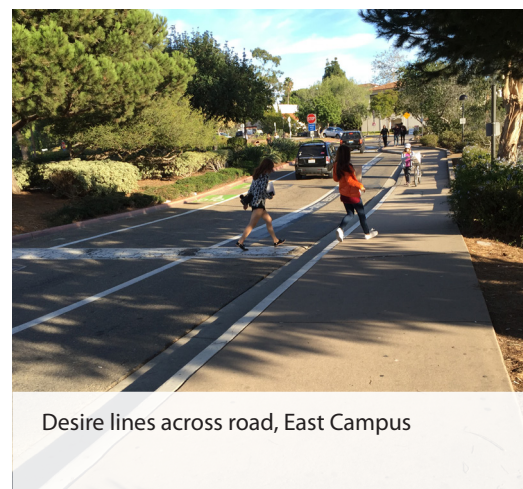
Desire lines across road, East Campus

- Students cross roads and parking lots when it provides the most direct route, causing safety hazards.

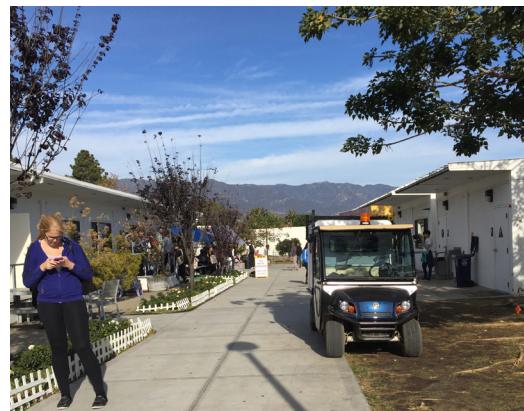
service vehicles on pedestrian paths

- Service vehicles use pedestrian paths, leading to adjacent landscape damage.

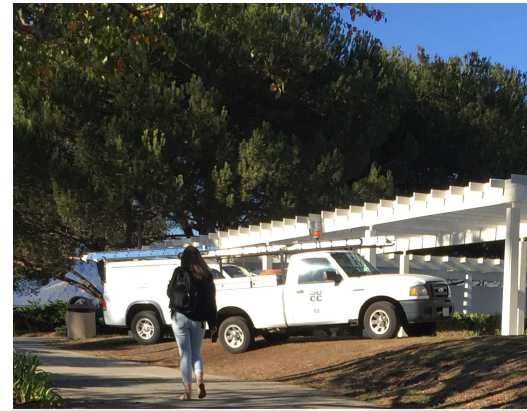
large service vehicles parked along pedestrian paths

- Large service vehicles cross pedestrian paths, causing potential paving and landscape damage and creating safety hazards.

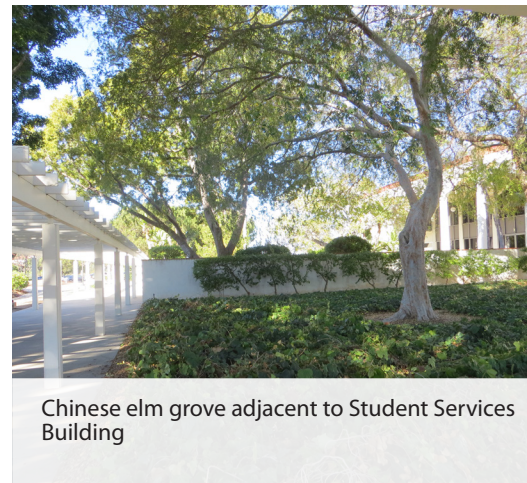
Chinese elm grove adjacent to Student Services Building

- According to SBCC's 2010 Tree Plan, these trees are in very good condition. The grove also helps define the spatial quality of the adjacent courtyard.

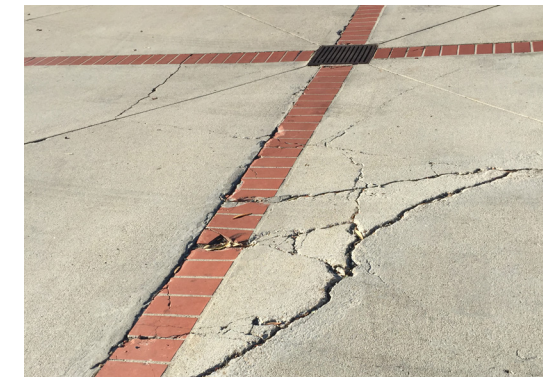
concrete with brick accents

- Some surfaces have moderate to severe cracking and uplifting.
- Concrete paving with brick accents is typically in fair to poor condition.

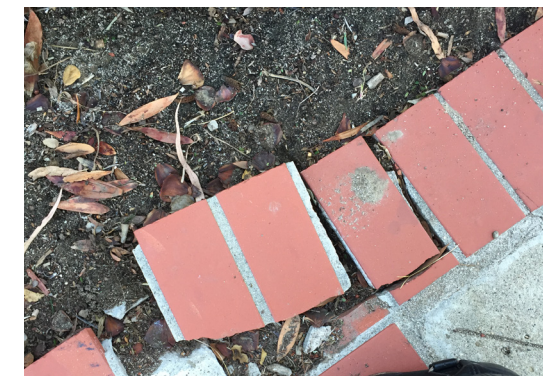
concrete with brick accents

- Failing paving edge with moderate to severe cracking and some loose and completely detached brick.
- Mortar joints have deteriorated along paving edge.

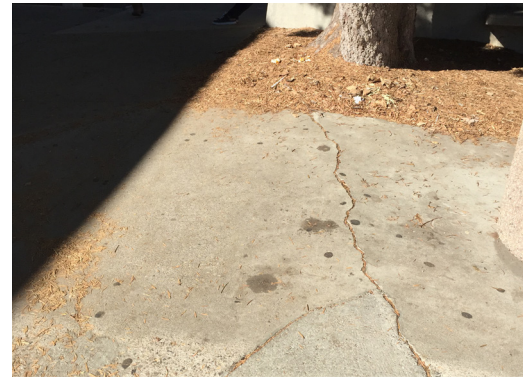
- In a few locations, trees are causing the concrete paving to crack and shift upward, creating a tripping hazard.

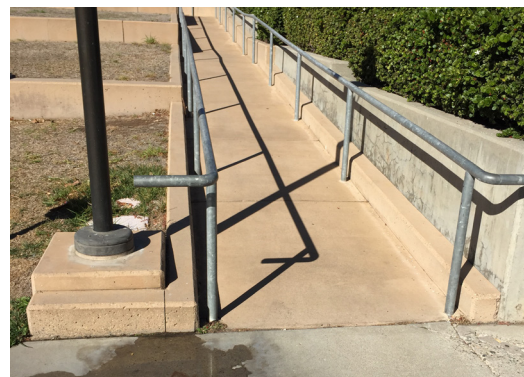
concrete with and without integral color

- Some surfaces are uneven and do not drain.
- Some expansion joints have minor to moderate cracking.

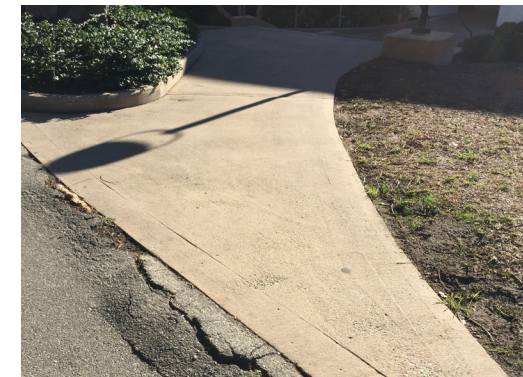
uneven surface and cracking at paving transition from asphalt to concrete

- Transitions from asphalt to other paving types are often uplifted and have moderate cracking, creating tripping hazards.

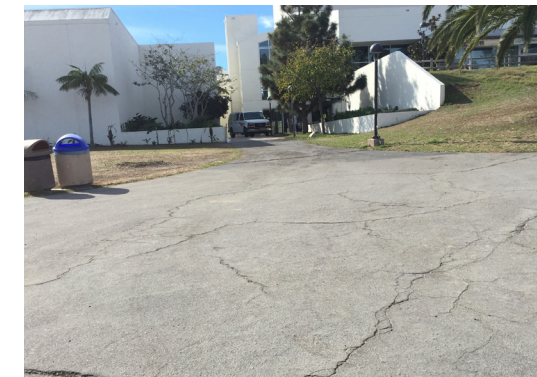
asphalt block cracking

- Many asphalt surfaces have minor to moderate block cracking, with some cracks larger than 1/4".

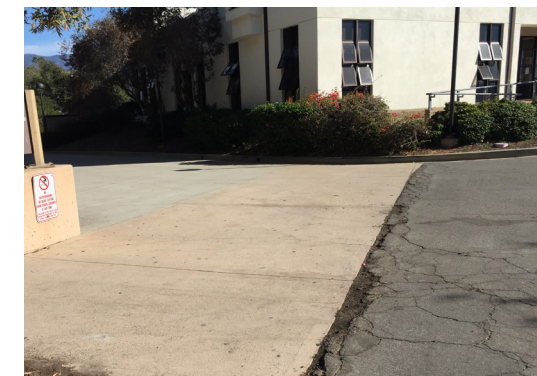
alligator cracking and deterioration at paving transition

- Transitions from asphalt to other paving types are often uneven and have moderate to severe cracking and surface deterioration.

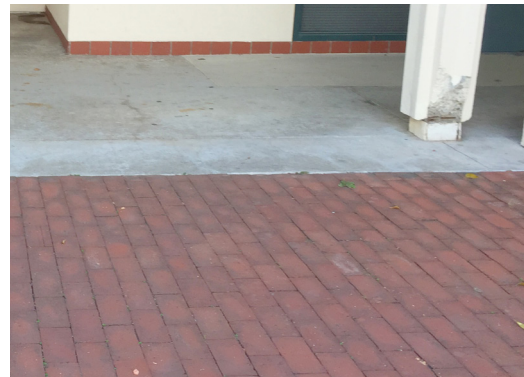
sand set brick

- Sand set brick requires additional maintenance for removal of weeds and debris.

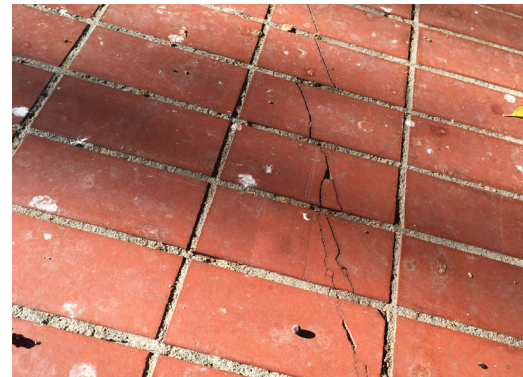
mortar set brick on concrete slab

- Aging mortar set brick has cracking and deterioration of grout joints.

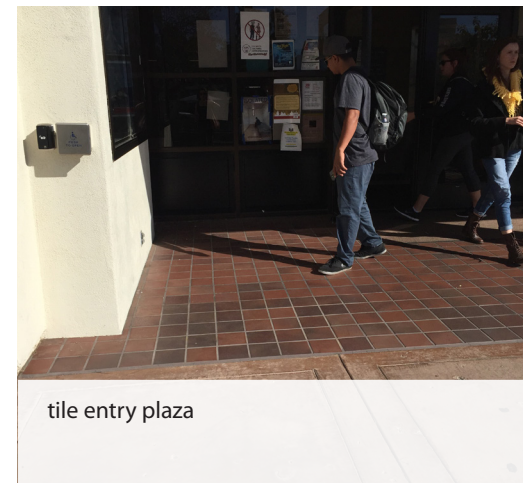
tile entry plaza

- Tile is used to pave the areas adjacent to doorways in building entry plazas.
- These entries are typically in fair condition.
- Tile typically does not comply with the coefficient of friction requirements for exterior installations and can get slippery.

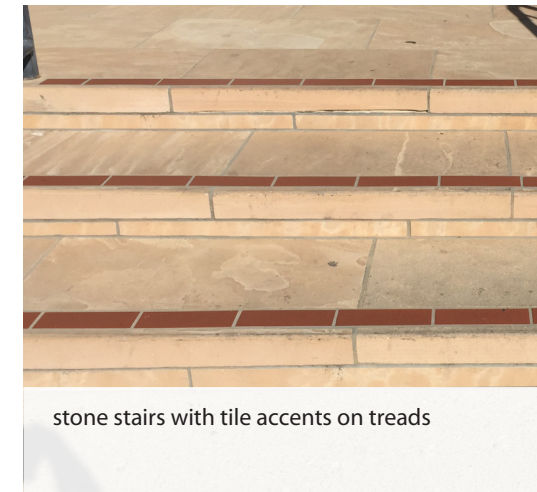
stone stairs with tile accents on treads

- Stone paving is used minimally. Santa Barbara sandstone is preferred type of stone on campus.
- Stair treads do not meet code. A grooved edge on treads is required.

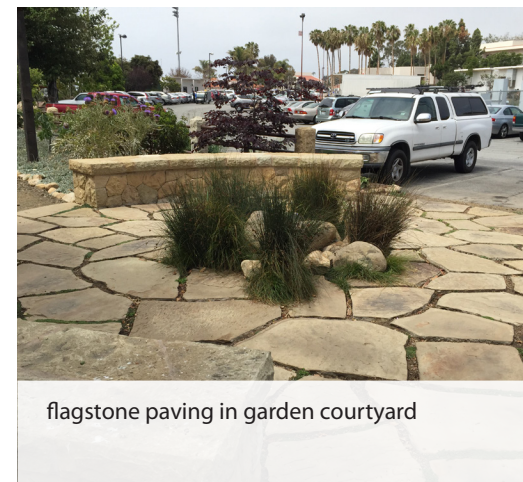
flagstone paving in garden courtyard

- Found at building entries, overlooks and gardens, the use of irregular stone pieces with wide joints in many places is more appropriate for a residential setting.
- Joints between stone pieces are typically wider than 1/4" and are non-compliant.

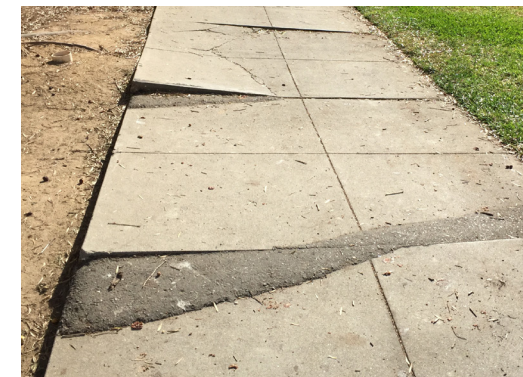
concrete sidewalk

- Portions of the sidewalk have uneven surfaces with minor to moderate cracking and some patching.
- Construction joints, especially those between asphalt and concrete, are typically wider than 1/4".

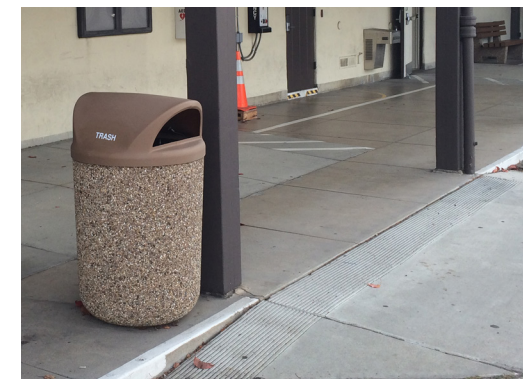
concrete ramps

- The transition from the parking lot to the pedestrian arcade walk lacks tactile warning pavers.
- Much of the walkway is raised 2-3" above the parking lot.

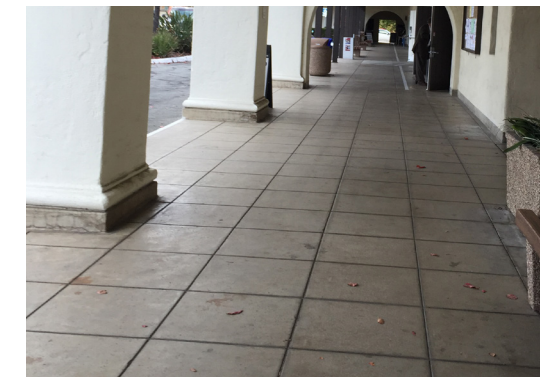
concrete arcade walk

- A small portion of the concrete paving in the arcaded walk has some minor cracking.
- Otherwise this paving is in good to fair condition.

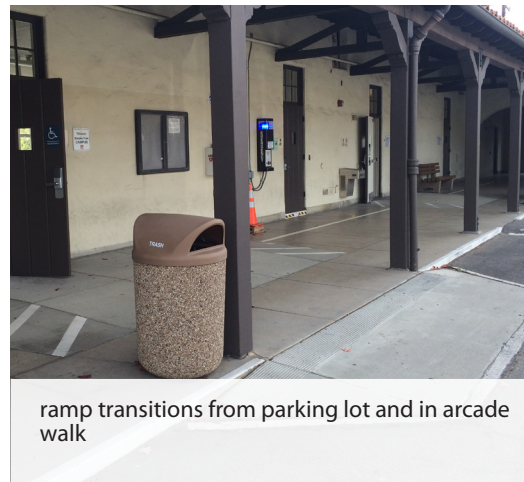
ramp transitions from parking lot and in arcade walk

- In most places, the arcade walk is only accessible by ramp, as it is 2-3" above adjacent parking lot paving.
- Some doors are also only accessible by ramp.

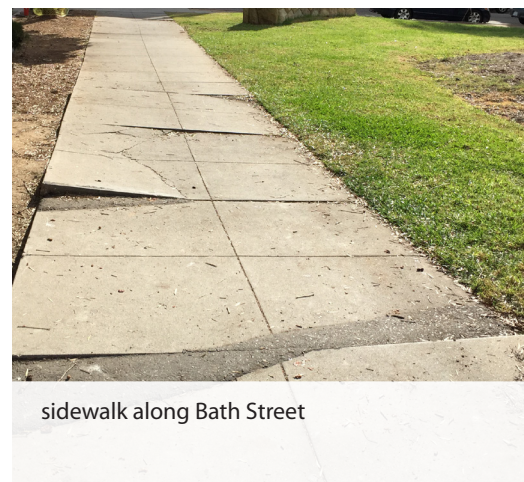
sidewalk along Bath Street

- The sidewalk has uplifting and poor patching, creating tripping hazards and accessibility issues.

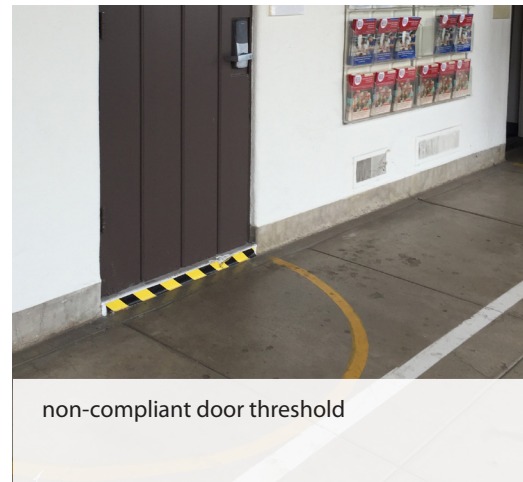
non-compliant door threshold

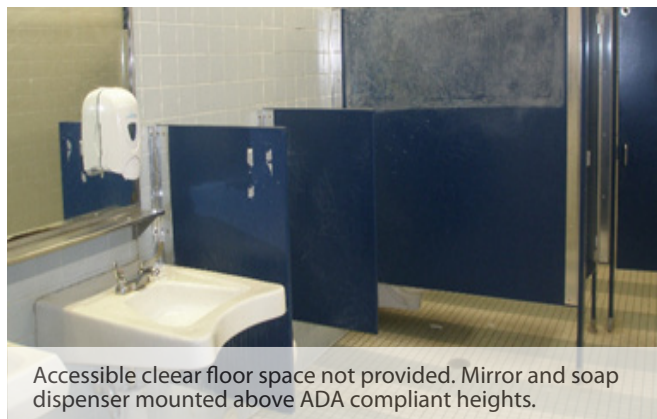
- The finishes are in fair condition, but are aging and in need of refurbishment. Multiple toilet partitions have been purposely defaced and should be replaced with products better suited to withstanding vandalism.
- Although the layout and configuration of the restrooms are relatively efficient, they were originally designed to meet 1988 ADA standards, and are unlikely to be in compliance with current codes. It is apparent that many components of the restroom no longer provide adequate accessible dimensional clearances.

Accessible clear floor space not provided. Mirror and soap dispenser mounted above ADA compliant heights.

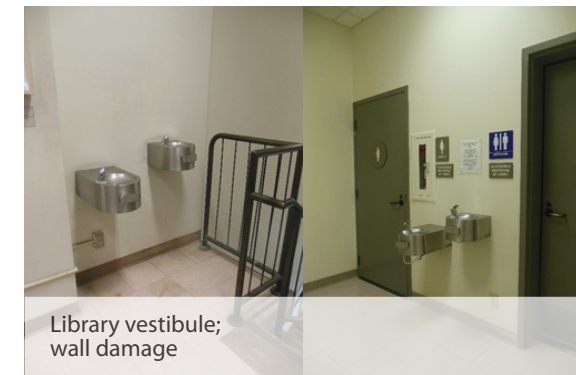
Library vestibule; wall damage

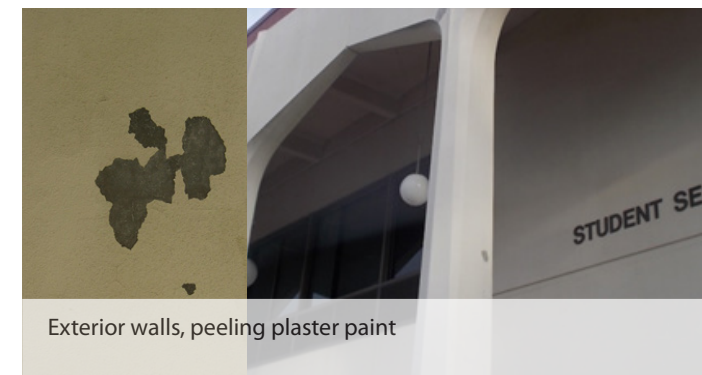
Exterior walls, peeling plaster paint
