Santa Barbara City College

SBCC Campus & Building Assessments Report

April 2016

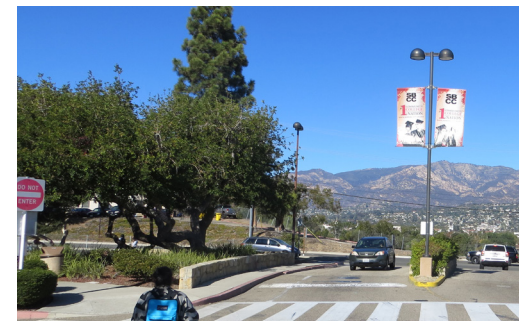
East Campus main entrance

- This entrance is heavily used by vehicles, pedestrians, bikes, and buses.
- Many modes of transit overlap haphazardly in this area, in particular pedestrians crossing through the vehicular lanes, to get to the bus stop.

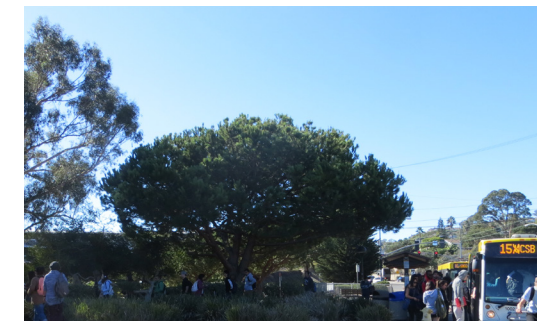
Bus stop at East Campus main entrance

- The bus stop is heavily used, and not large enough to accommodate the number of people waiting in and moving through the space.
- Pathways to the bus stop are not direct and students frequently utilize roads to get to the stop.

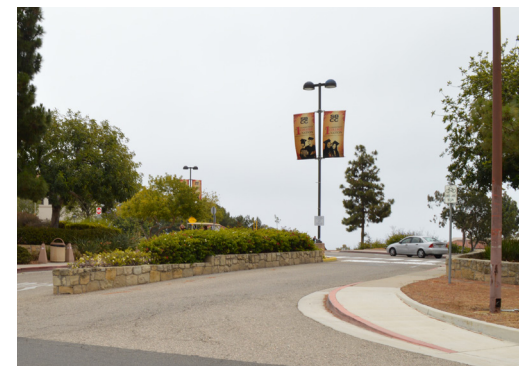
East Campus main entrance

- A raised planter separates traffic at the East Campus entrance, blocking site lines.

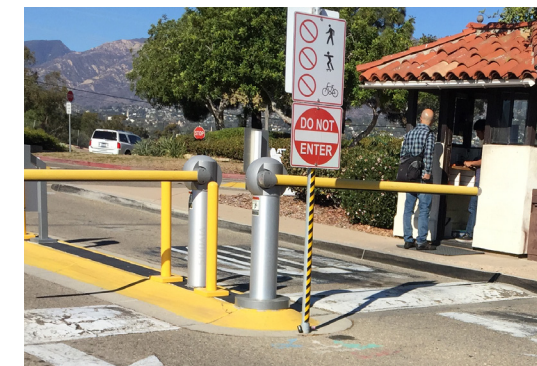
East Campus main entrance kiosk

- Upon arriving at East Campus, wayfinding is unclear, especially for pedestrians.
- Cars back up at kiosk, causing congestion.

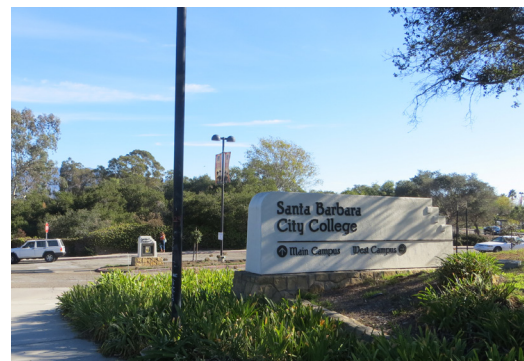
West Campus main entrance

- This entrance is primarily used by vehicles, though pedestrians and bikes have designated space.
- The entry sign is visible from Cliff Drive, however, site lines to this sign are poor.

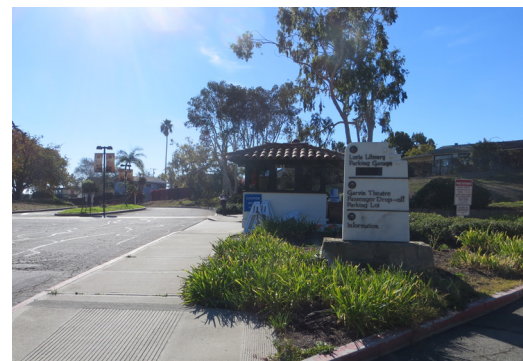
West Campus main entrance, kiosk

- This kiosk greets visitors as they arrive on west campus, however, there is little else to provide a sense of arrival or direction at this entrance.

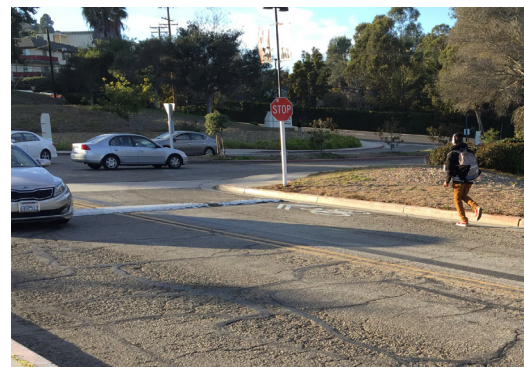
West Campus main entrance

- Students walk in the road, trying to find the most direct route.

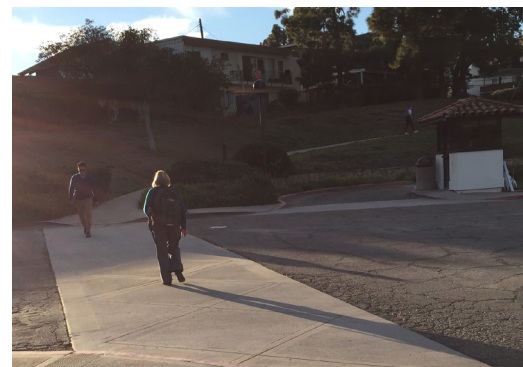
West Campus main entrance

- Traffic does not have a stop sign at this intersection or at the kiosk.

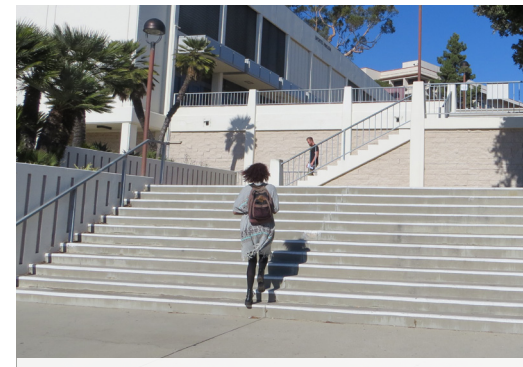
Sports Pavilion pedestrian entrance from Lot 2B

- Pedestrian access to East Campus from the lower parking lots is particularly indirect. Due to the terrain, mazes of stairs and ramps lead into the campus.

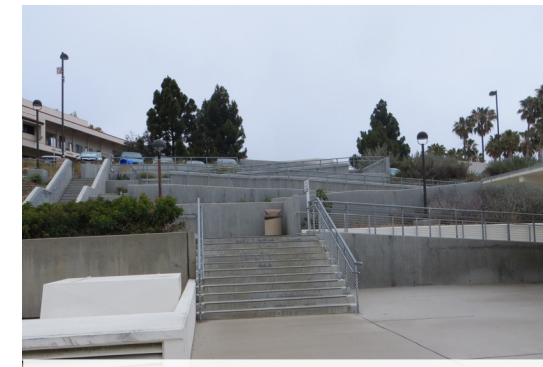
Sports Pavilion pedestrian entrance from Lot 2B

- Stairs and ramps continue past the Sports Pavilion. These must be traversed in order to reach the core of East Campus from the lower parking lots.

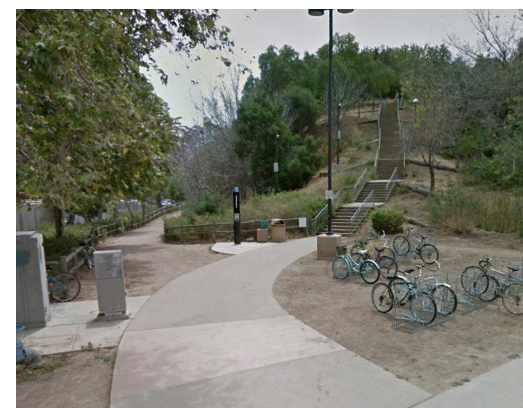
Cliff Drive Pedestrian Entrance

- Topographic change visually separates the Cliff Drive entrance from the campus.

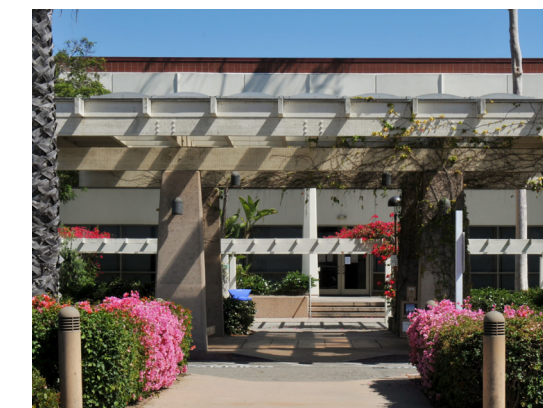
Passenger drop off area by student services

- There is little signage or other wayfinding devices to orient visitors at this drop off.

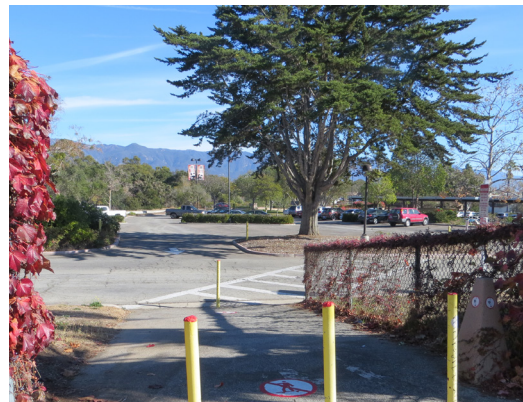
Del Sol West Campus Pedestrian Entrance

- Pedestrian and bike entrances at Del Mar and Del Sol Avenues are poorly framed, but heavily used by the community.

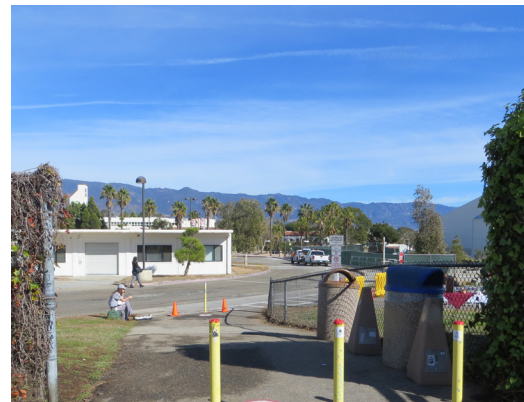
Del Mar West Campus Pedestrian Entrance

- The entrances themselves poorly announce transition into the campus causing regulatory issues such as littering.

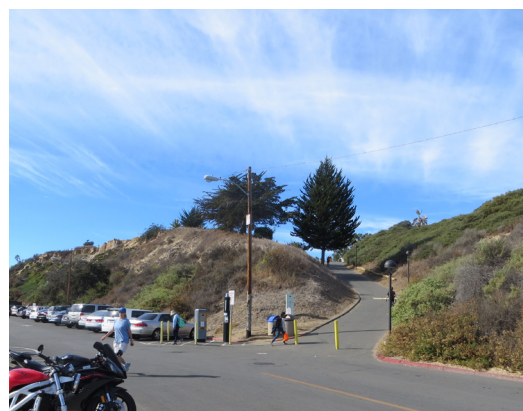
Lot 3 Pedestrian Entrance

- There is little wayfinding or sense of arrival at the thresholds between the parking lots and the campus paths. Due to the terrain, accessibility is an issue.

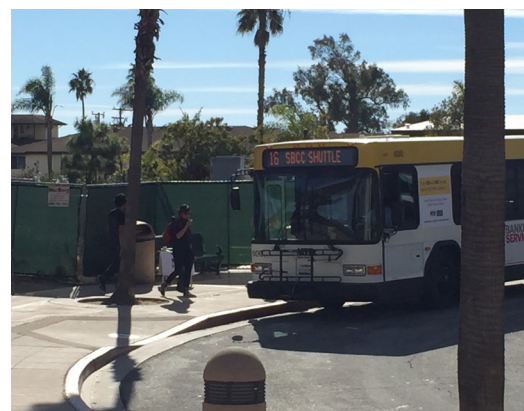
Bus stop at West Campus drop off circle

- This bus stop lacks seating and shelter and competes for space with passenger loading.
- There is little sense of arrival at this entry.

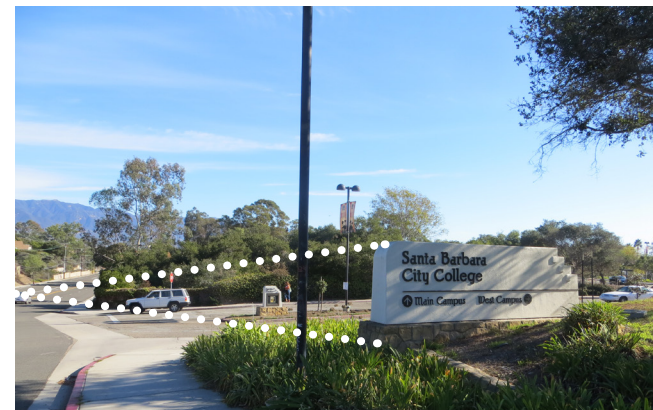
West Campus Entrance signage
 • Signage is not easily seen from Cliff Drive.

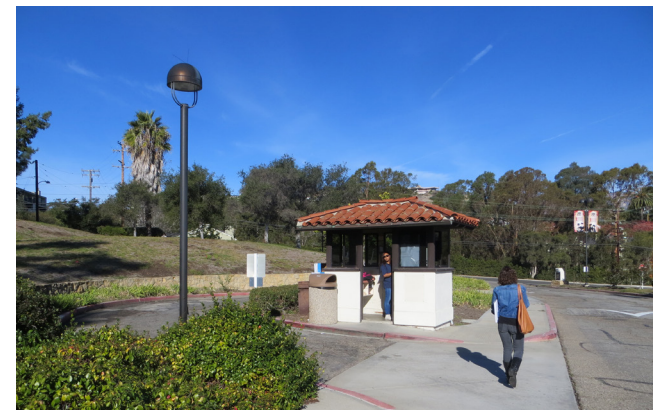
West Campus Entrance kiosk
 • Traffic exiting kiosk crosses pedestrian pathway and enters roadway without a stop sign.

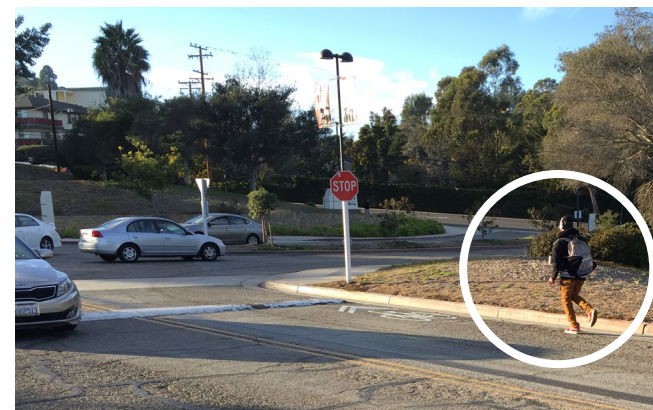
West Campus Entrance, desire line
 • Students walk dangerously in roadway.

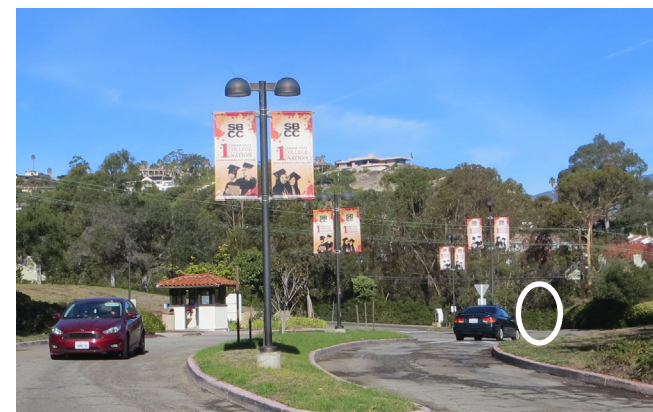
West Campus Entrance intersection
 • No stop sign at intersection

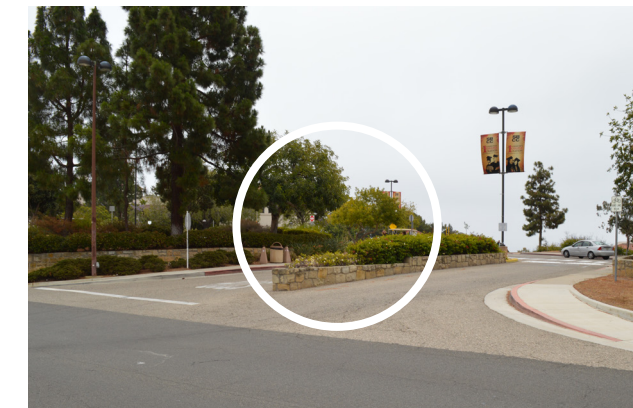
East Campus entrance
 • No signage announces the main East Campus entrance.

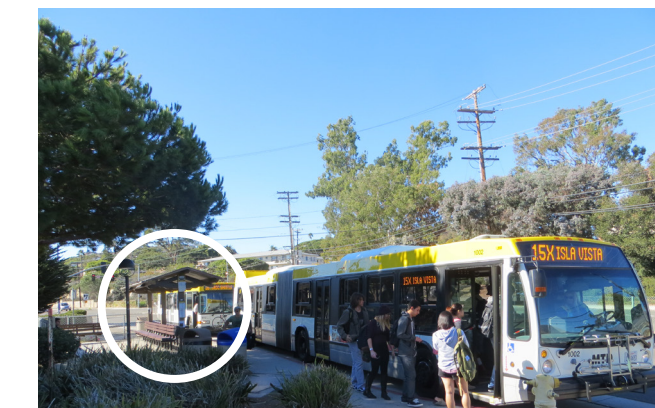
East Campus bus stop
 • The bus shelter and connecting pathways are poorly located in relation to embarking and disembarking.

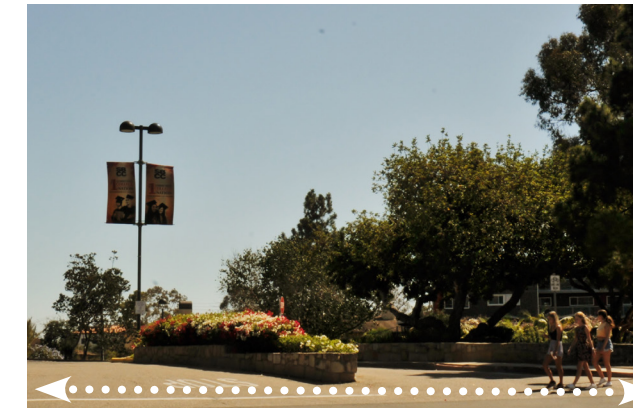
East Campus entrance
 • No crosswalk connects the sidewalk along Cliff Drive.

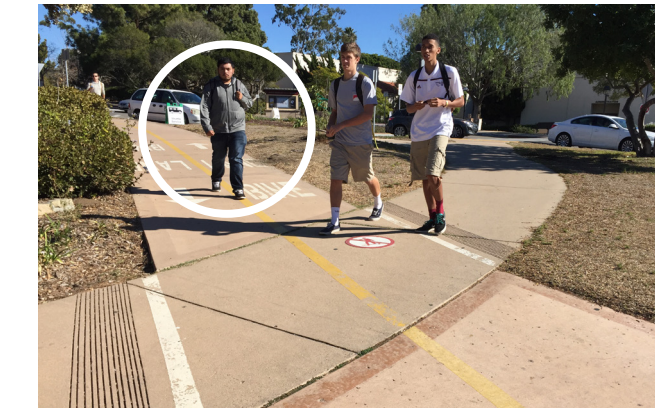
Bike lane at East Campus entrance
 • Bikes and pedestrians conflict along the only path dedicated to bikes on campus.

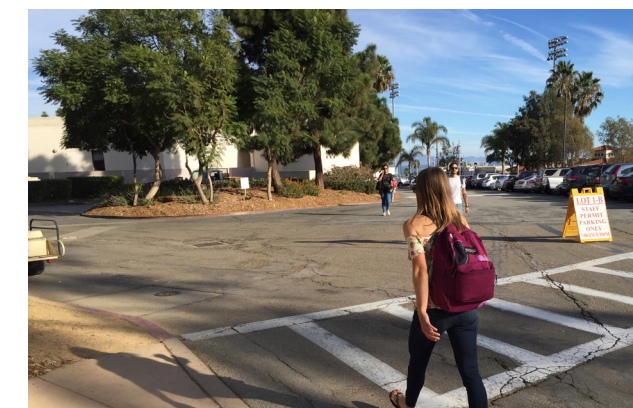
East Campus Entrance, roadway + crosswalk
 • Students walk dangerously in the road as crosswalks and sidewalks do not provide a direct route.

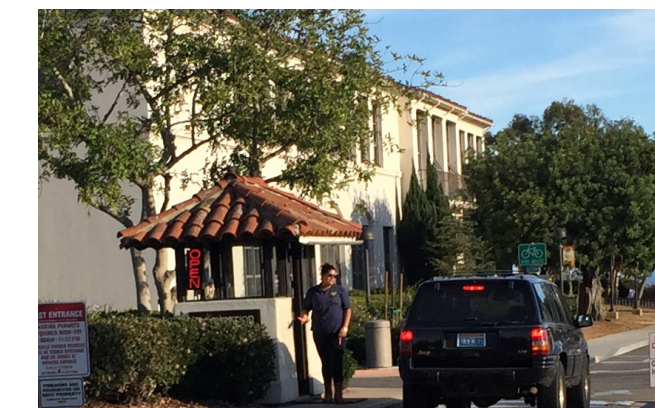
East Campus Entrance kiosk
 • Vehicles stack as some wait to stop at kiosk and others try to access parking.

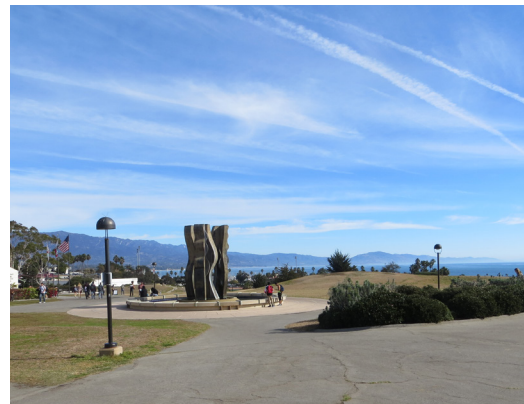
Primary pedestrian path, West Campus

- The primary path through campus lacks a clear sense of direction.

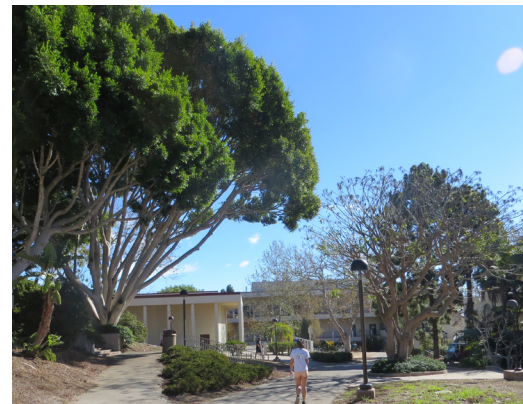
Secondary pedestrian path, East Campus

- Secondary paths are often circuitous, and due to slope and materials, are noncompliant.

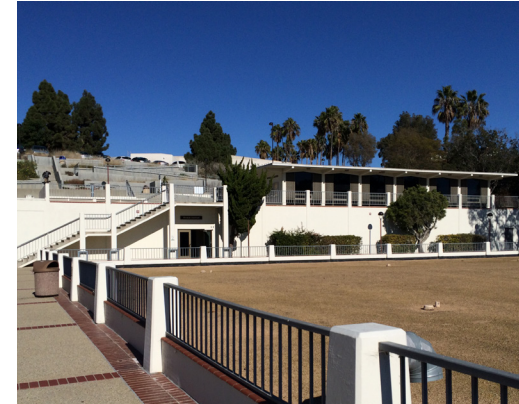
Accessible route near Sports Pavilion, East Campus

- Accessible routes are often indirect and confusing to navigate.

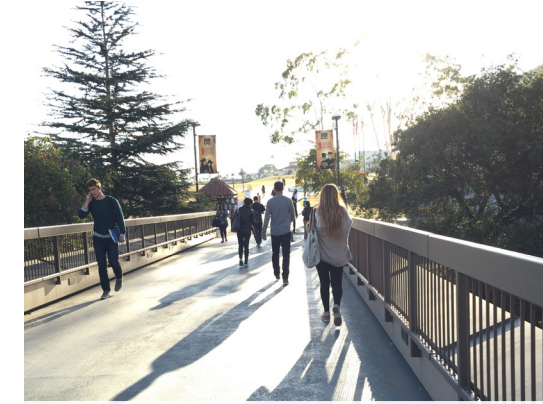
Primary pedestrian path, Loma Alta Bridge

- Loma Alta Bridge is the only pedestrian connection between East and West Campus.

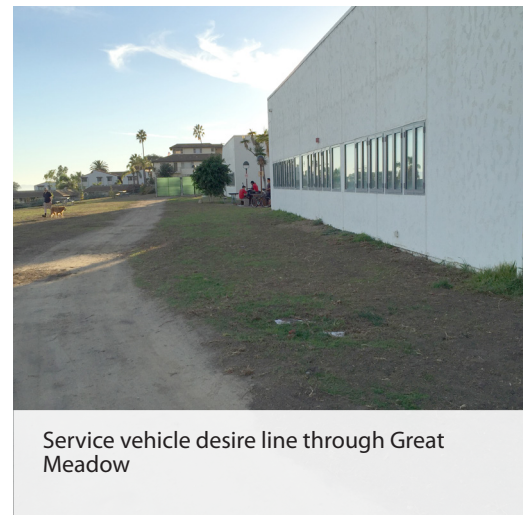
Service vehicle desire line through Great Meadow

- Campus service vehicles also use desire lines when a direct connection is not available.

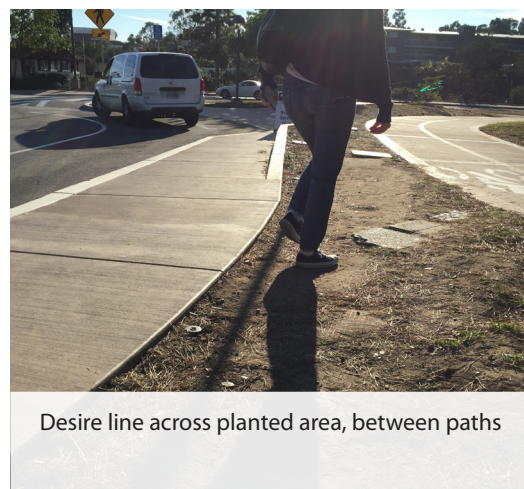
Desire line across planted area, between paths

- Students cut across planted areas between paths, damaging vegetation.

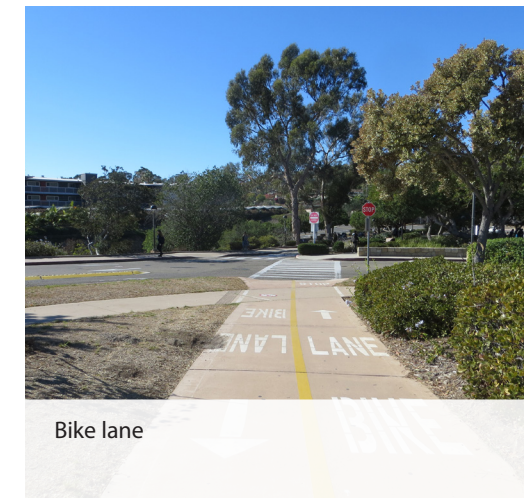
Bike lane

- The campus only has one pathway just for bikes, which parallels Cliff Drive on East Campus.

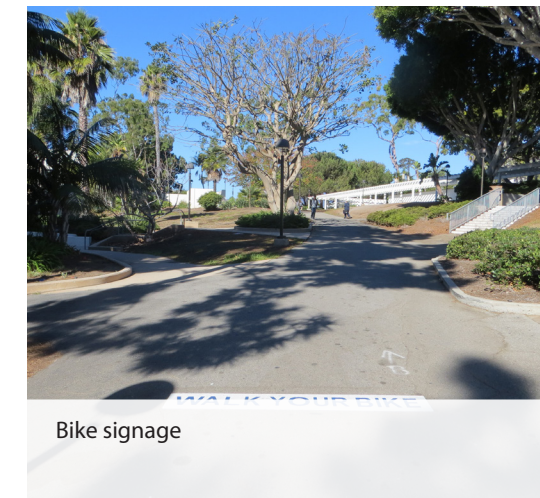
Bike signage

- Through most of campus, bikes are meant to be walked, not ridden.

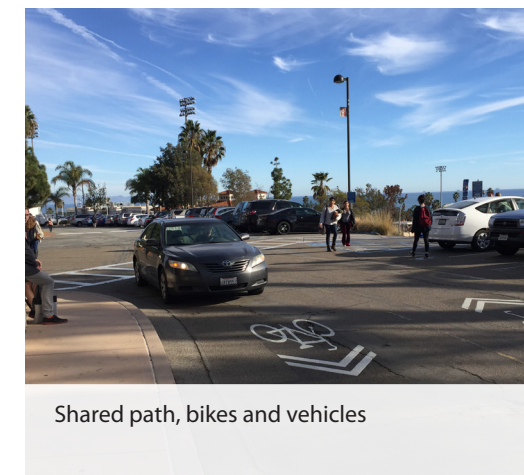
Shared path, bikes and vehicles

- Bikes typically share space with vehicles on campus.

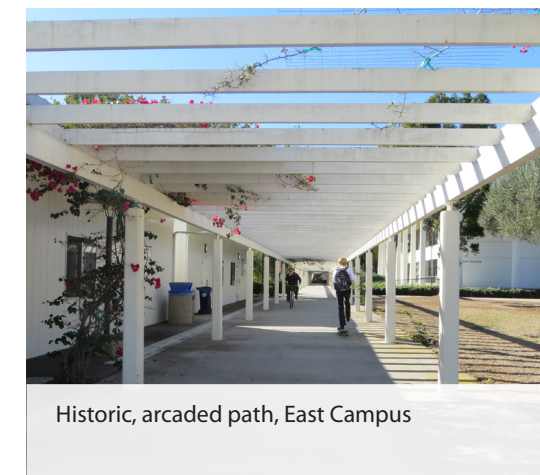
Historic, arcaded path, East Campus

- Bikes and skateboards often share pedestrian paths.

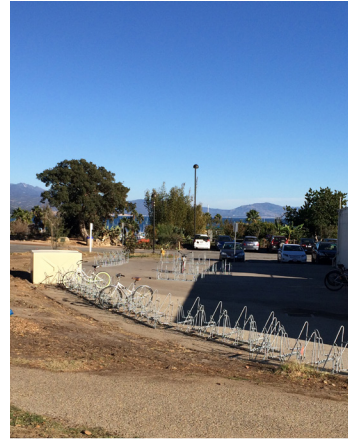
Over-abundant bike parking on East Campus

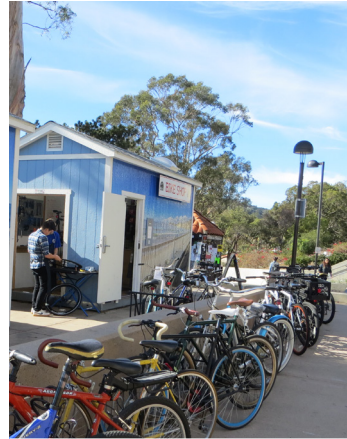
Bike parking and service on East Campus

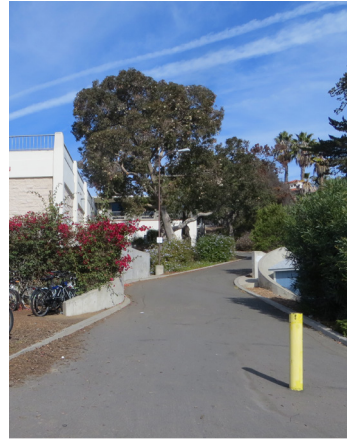
Over-crowded bike parking at Lot 2C entrance

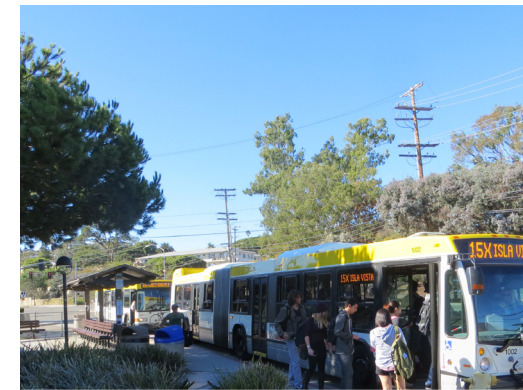
bus stop, East Campus

- This bus stop lacks adequate space to accommodate arriving and departing passengers comfortably and safely.
- People embark and disembark far from the path that leads to the stop, causing students to use the adjacent roads to access the stop.

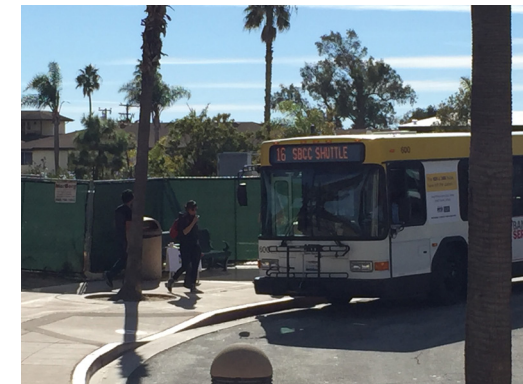
bus stop, west Campus

- This bus stop lacks shelter or seating and competes with passenger loading at the same location.

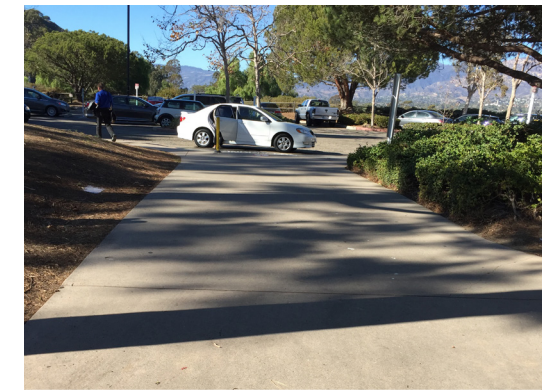
passenger loading by Student Services, East Campus

- Passenger loading areas tend to lack sufficient campus orientation or wayfinding.
- These areas are scattered across campus, as opposed to being centralized.

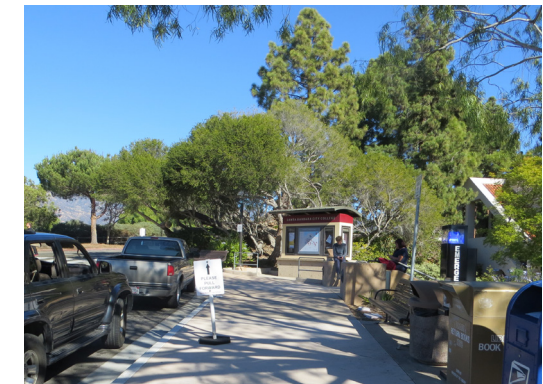
passenger loading by Administration, East Campus

- Passenger loading zones are often overcrowded with vehicles.

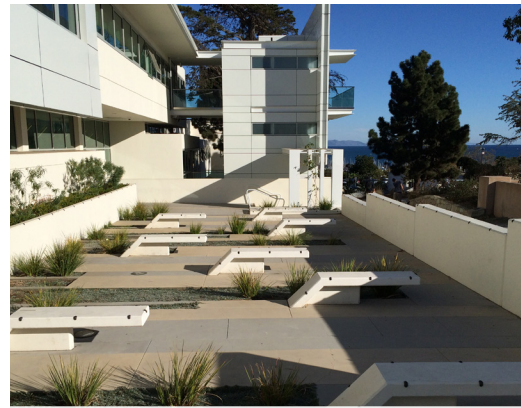
Humanities Building Courtyard

- This courtyard is not easily visible or accessible from the building or adjacent path.
- The seating is inflexible and uncomfortable and there is no relief from direct sun.

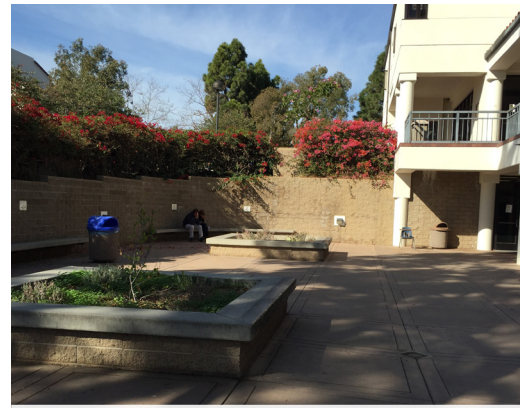
Interdisciplinary Center Courtyard

- This courtyard is hidden, underutilized and lacks any notable landscape features.
- The tall walls are forboding and make the space feel sunken.

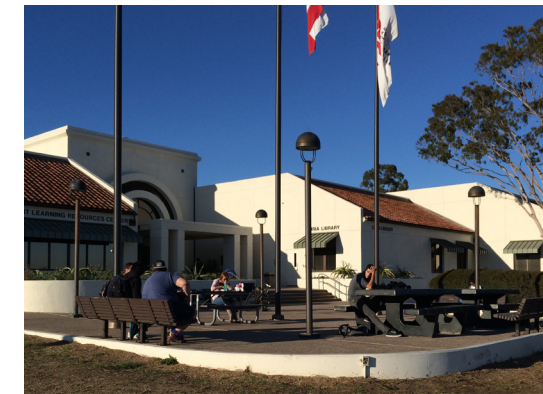
Luria Library Entrance Plaza

- This plaza is highly visible and has ocean views, however, there is little shade and furnishings do not support a range of activity.

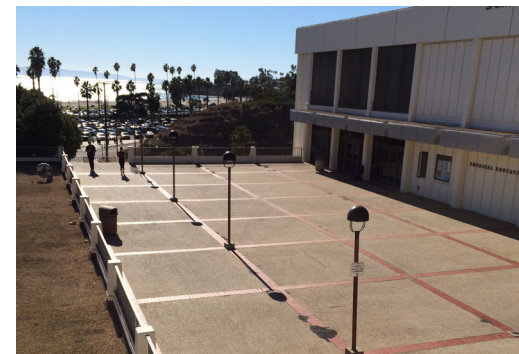
Sports Pavilion Plaza

- This plaza is vast and empty lacking furnishings or shade.
- People move through this space without lingering.

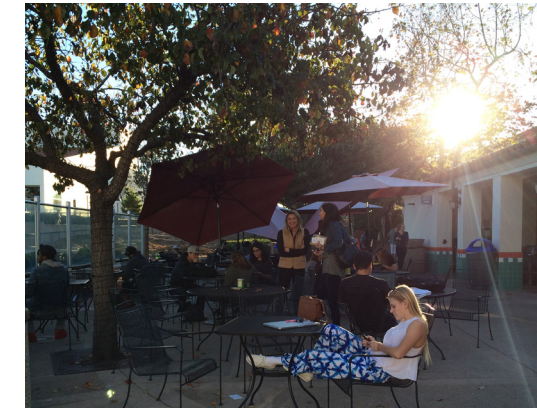
West Snack Shop

- Located by the only dining facility on the East Campus, this dining plaza is often crowded.
- Wind screens define the space and restrict flexible expansion during busy times.

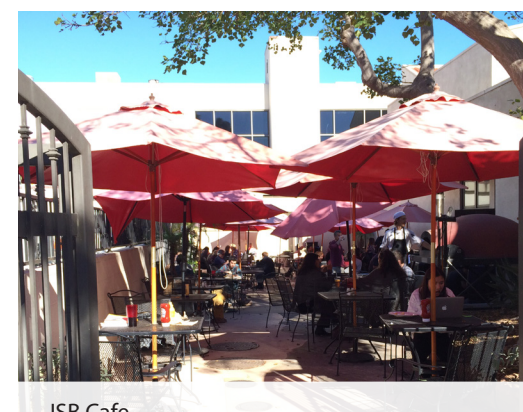
JSB Cafe

- This dining area is very popular and typically crowded.
- Walls and gates define and constrict space, there is limited ability to even circulate.

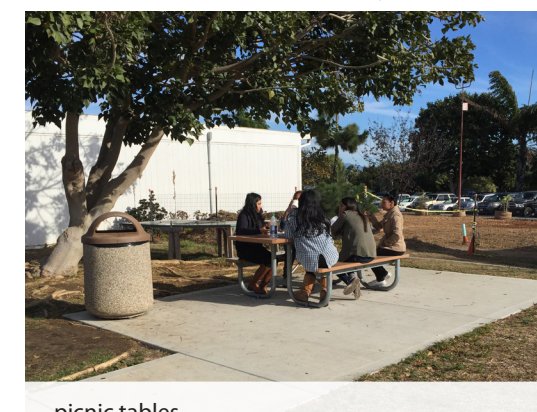
- Sporadically placed across campus, picnic tables offer a quieter, more intimate outdoor dining experience.
- Many are randomly sited and offer little sense of place.

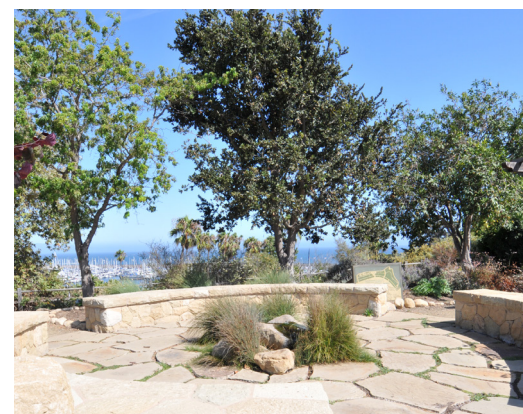
Courtyard in Lifescape Gardens

- While the scale of this space provides an intimate setting, there is little shade.

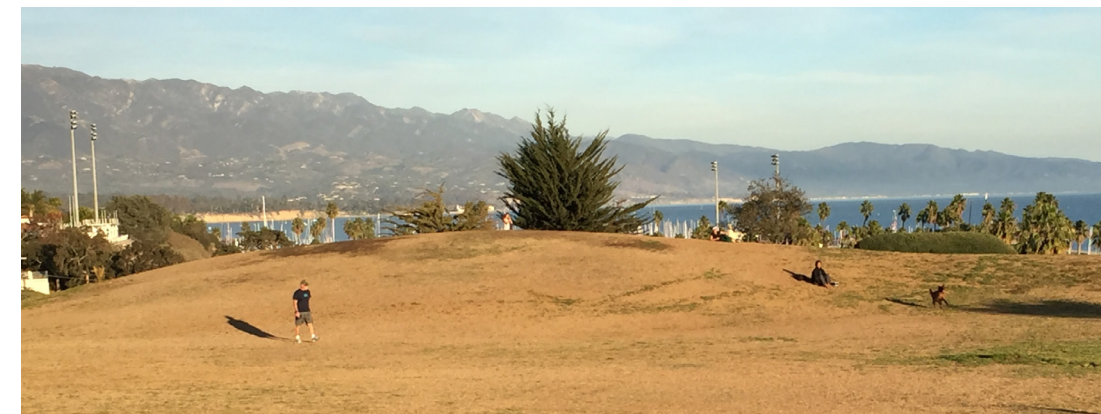
Great Meadow

- The Meadow is often used by the community as a dog park.
- Due to the drought, irrigation has been turned off and the dry turf grass is perhaps less inviting for gathering than it once was.

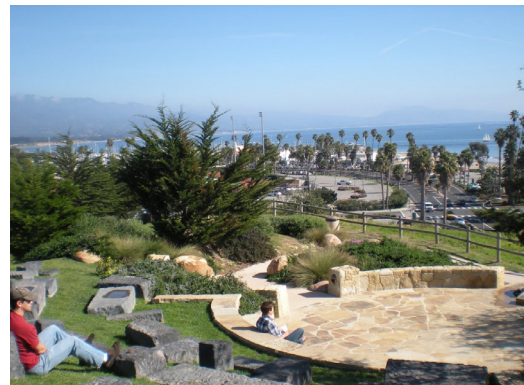
- Bagish Overlook is well-used due to attractive views.
- The materials of the site are incohesive and busy, distracting from the view beyond, and accessibility is a concern.

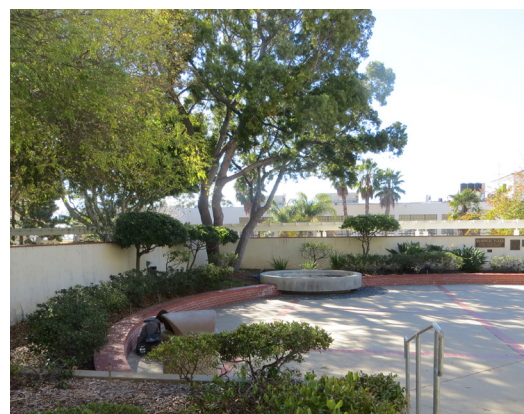
memorial plaza by Student Services

- This walled space is large and underutilized with seat walls that do not promote socializing or lingering.

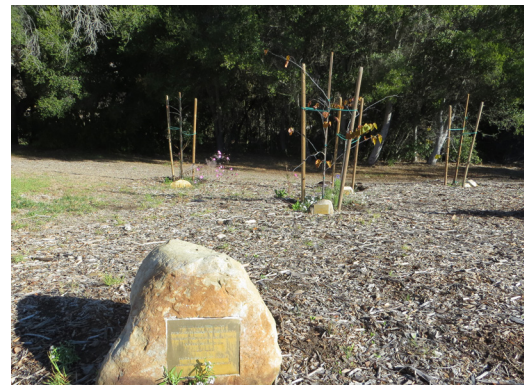
memorial monuments at West Campus entrance

- These memorials stand alone in a low-traffic area, are unrelated to other memorials on campus, and are not connected to any defined pathway.

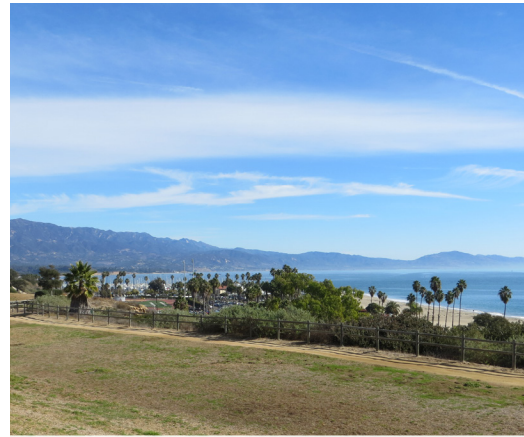
- Open space and expansive views support gathering and activity.
- The Great Meadow has some patches of dry, brown turf due to the drought and subsequent irrigation shut-off.

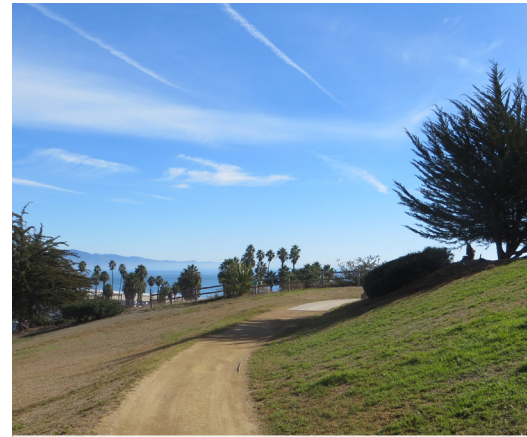
Great Meadow, pedestrian path

- Dirt paths for pedestrians and small service vehicles connect overlooks while cutting through the landscape.

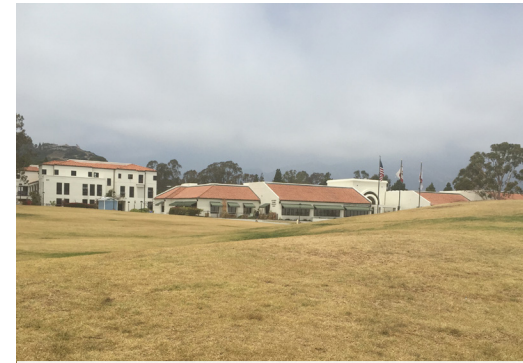
- The Meadow's gently rolling topography supports gathering and activity.
- The Great Meadow has areas of dry, brown turf due to the drought and subsequent irrigation shut-off.

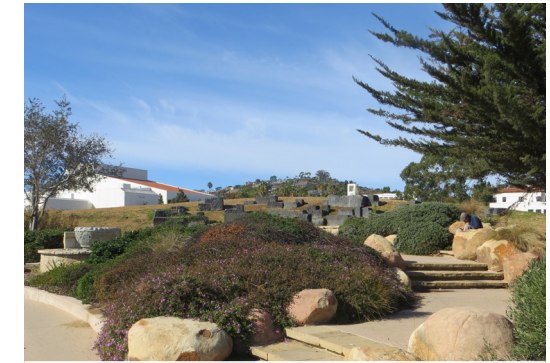
Great Meadow

- Overlooks carve into the meadow.

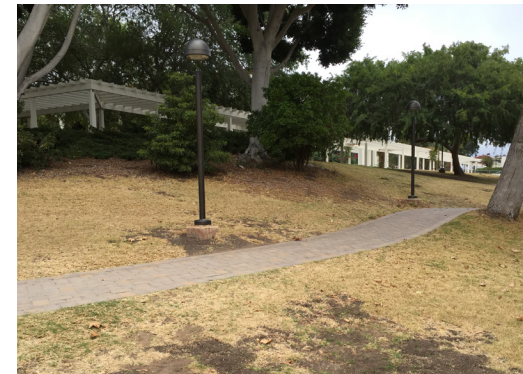
open lawn with some mixed planting

- Additional areas of lawn also have dry, brown turf due to the drought and subsequent irrigation shut-off.

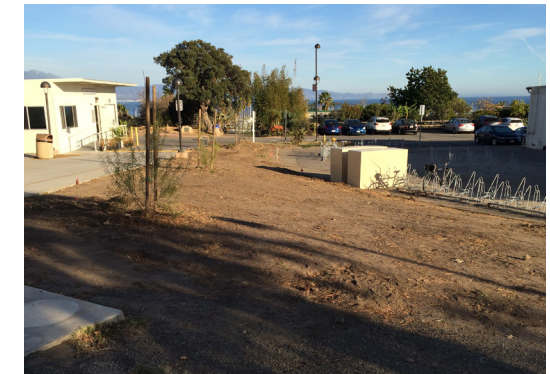
bare earth

- Areas previously covered with lawn have become unsightly, patchy areas of dry turf and bare earth.
- These spaces are subject to weeds and soil erosion.

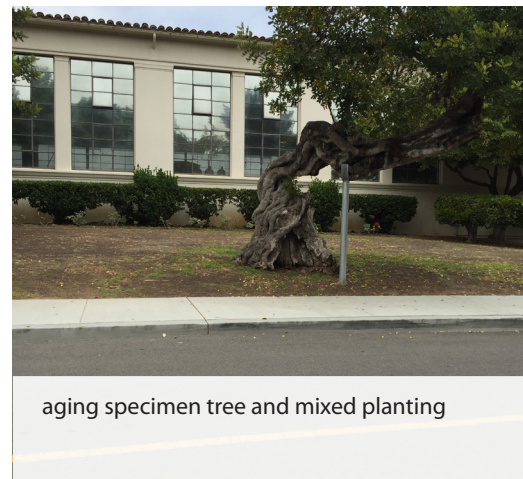
aging specimen tree and mixed planting

- The carob trees by the Administration Building are aging, structurally unsound, and in need of maintenance and eventual removal.

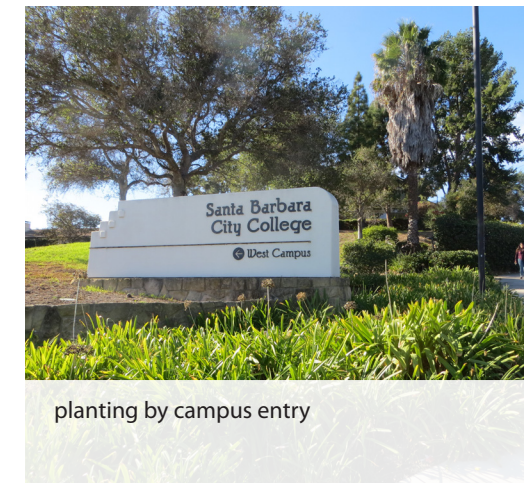
planting by campus entry

- The West Campus entry is defined by large swath of Agapanthus.
- Many older plantings do not comply with current campus sustainability goals.

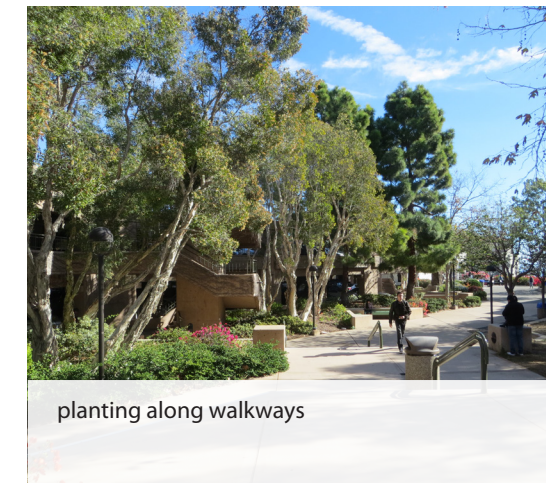
planting along walkways

- Many mixed planting areas appear eclectic, unplanned, and irregular.

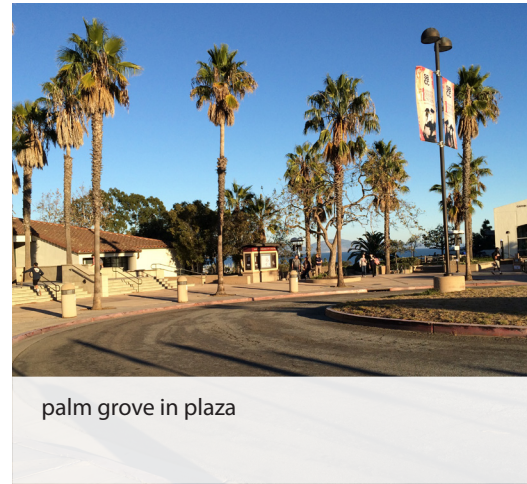
palm grove in plaza

- Palms add identity and spatial structure to an entry plaza and drop off area in west campus.
- Throughout campus, many palm fronds need removal.

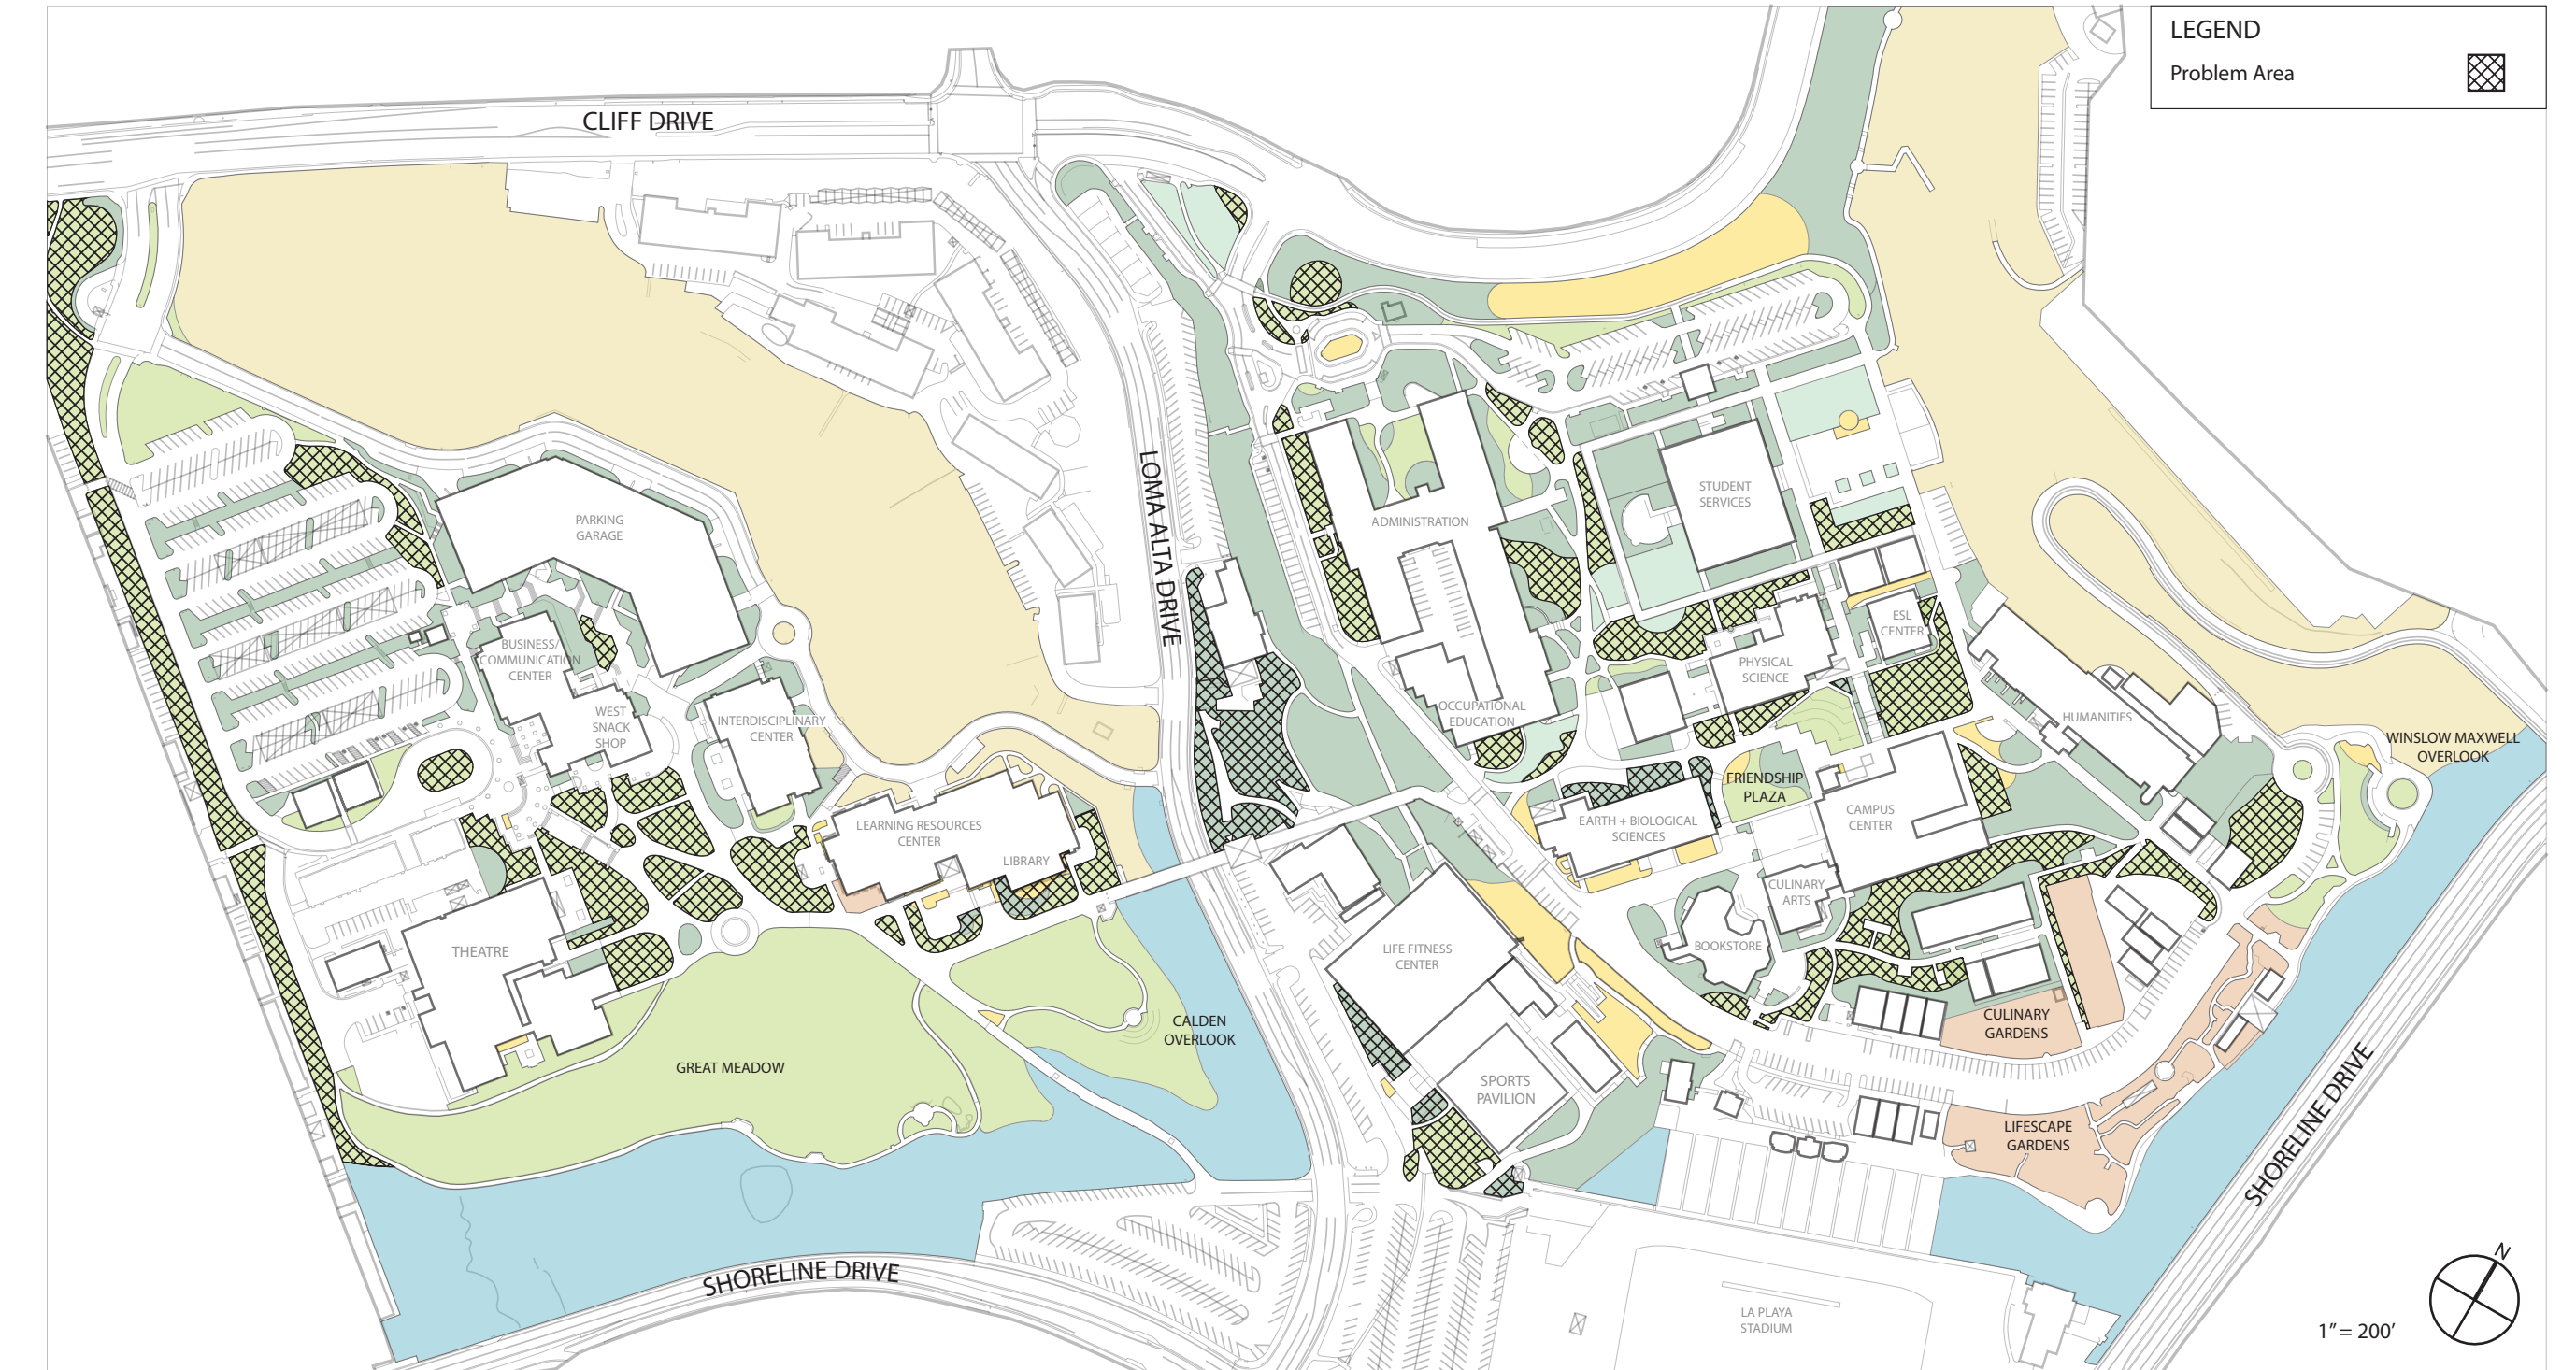
LANDSCAPE PROBLEMS ASSESSMENT SITE PLAN

- The campus lacks current irrigation technologies including a master valve and pump regulator.
- There are fluctuations in water pressure and a lack of smart controllers with linked weather stations.

- Replacement of high water use plants with permaculture gardens is proceeding without a larger master plan in place.
- With exception to Great Lawn, Oak Woodland, and Coastal Bluff, the campus lacks a strong, compositional execution of plants that could strengthen a sense of place and streamline maintenance practices.

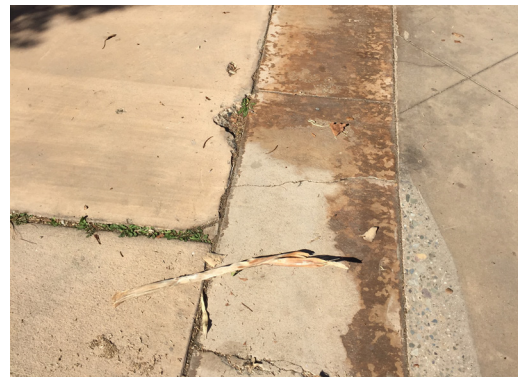
concrete with integral color

- Many joints are larger than 1/4", often uneven, and have minor to moderate cracking.
- Vertical uplifting at joints creates a tripping hazard and numerous areas around campus have been ground down.

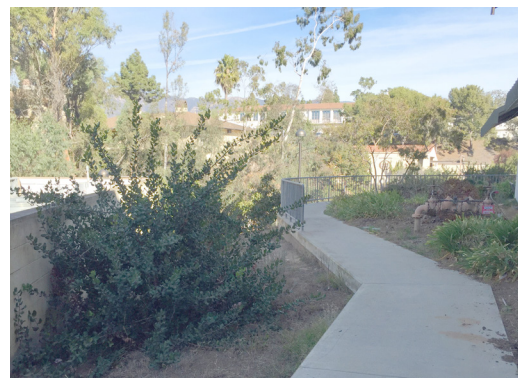
concrete walkway

- A few walkways and surfaces have a more than a 4" drop from pavement edge to the adjacent grade.

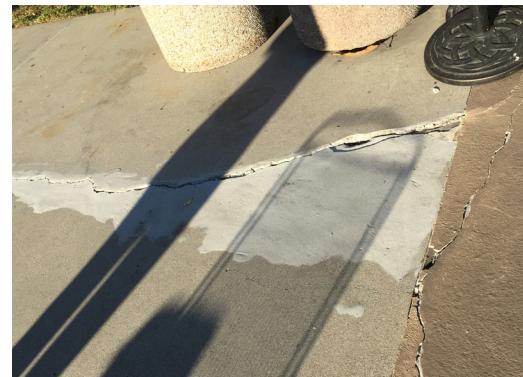
concrete with and without integral color

- Patching often does not match the surrounding paving and is poorly executed.
- While "Sombrero Buff" with broom finish is the standard for integral color concrete, colors and finishes vary greatly depending on age and location. This variation reduces overall pavement cohesiveness.

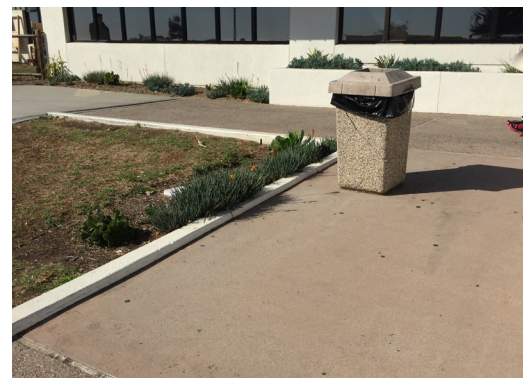
construction joint with sealant between concrete with exposed aggregate and concrete with integral color

- Many construction and expansion joints are larger than 1/4". Some are filled with sealant, and others have been patched with tar or asphalt.

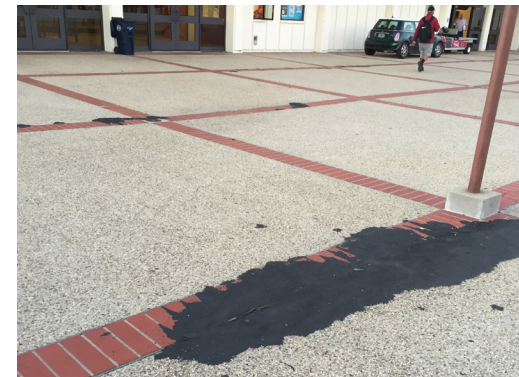
concrete with exposed aggregate and brick accents, patching

- Patching is often poorly executed and does not match the surrounding paving.
- Multiple paving types used on one surface increase maintenance demands.

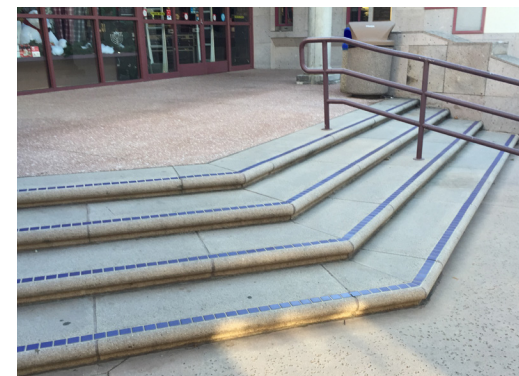
concrete stairs with tile accents on treads

- Tile accents on stair treads do not meet code. A grooved edge on tread nose is required.
- Paving in building entry plazas is typically in fair condition.

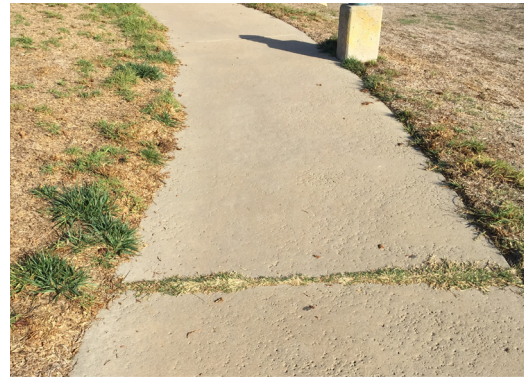
concrete with integral color

- A few pathways have exceptionally wide joints, with weeds emerging.
- Inconsistent finish of concrete contributes to lack of visual cohesion and is more difficult to maintain.

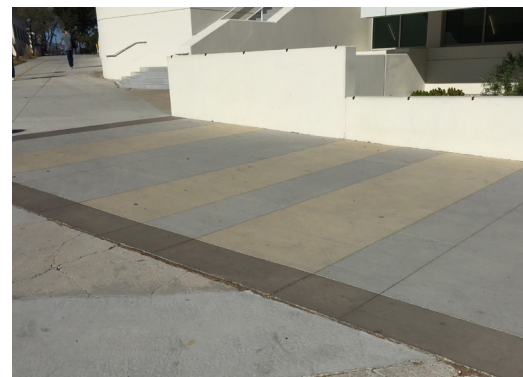
concrete with and without integral color

- Some areas have high degree of variation in concrete color and finish.
- Patching does not match the surrounding paving.
- Many construction joints are wider than 1/4".
