Santa Barbara City College

SBCC Campus & Building Assessments Report

April 2016

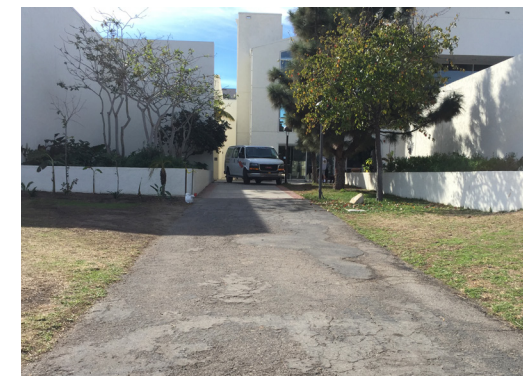
asphalt cracking and surface deterioration

- Some asphalt surfaces have moderate to severe cracking and deterioration.

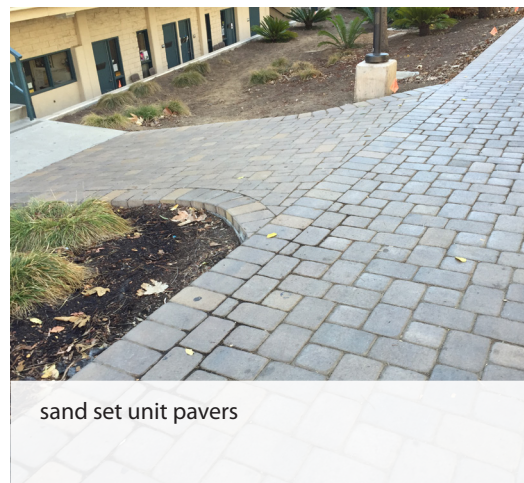
sand set unit pavers

- Pathways with unit pavers have more than 4" drop to adjacent grade in several locations.
- Sand set unit pavers require additional maintenance for removal of weeds and debris.

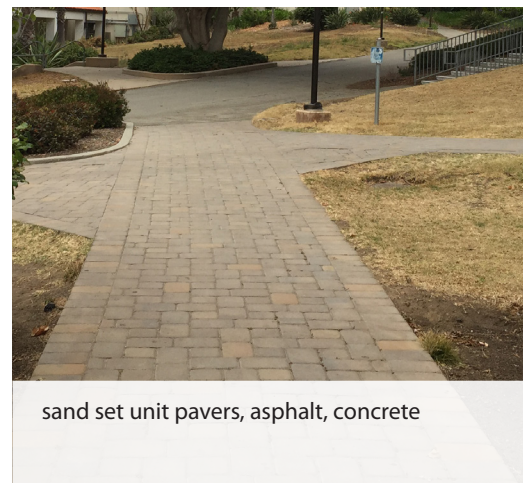
sand set unit pavers, asphalt, concrete

- Many areas of campus have an erratic use of paving materials.
- Changes in paving material make wayfinding confusing.

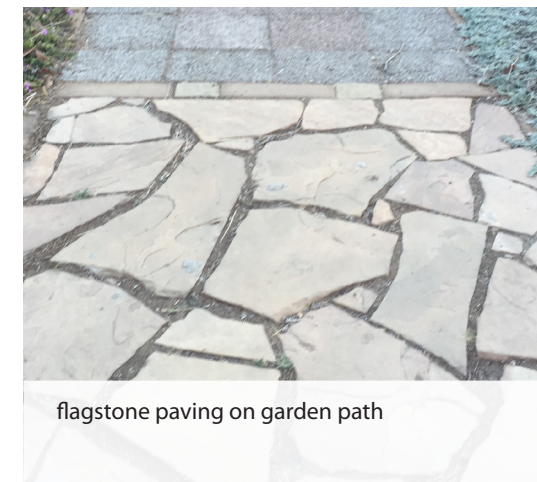
flagstone paving on garden path

- Joints between stone pieces are typically wider than 1/4" and are non-compliant.

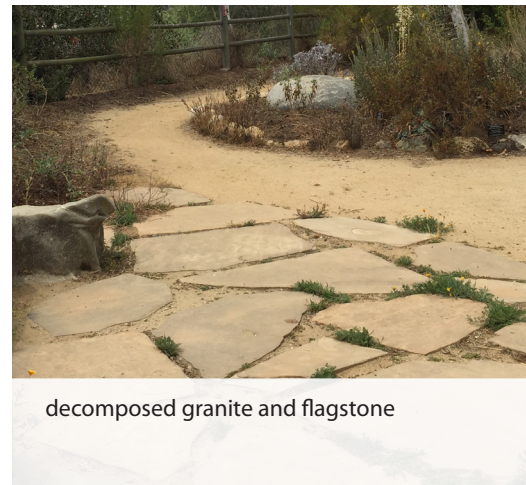
decomposed granite and flagstone

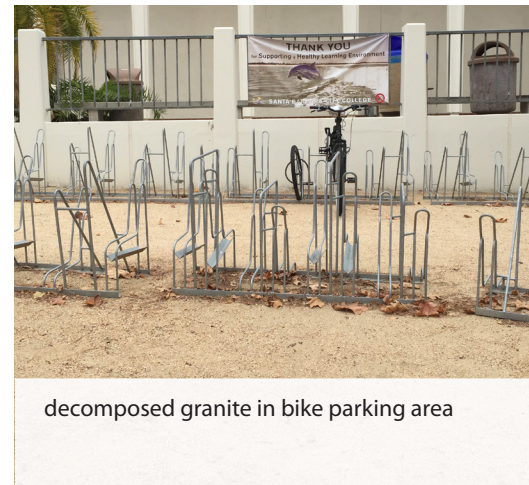
decomposed granite in bike parking area

- Transitions from DG to other surfaces are often uneven.
- DG is typically difficult to maintain.
- DG accumulates debris and can be tracked into buildings when wet.

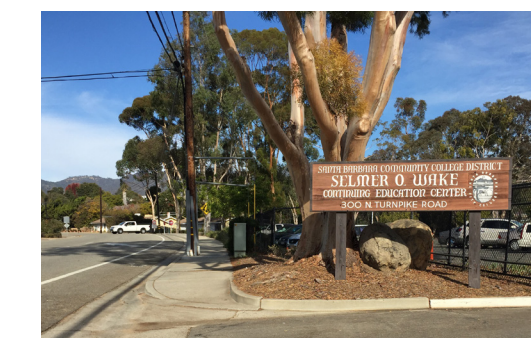
Wake Campus entry

- This sign is the main visible feature at the campus entry.
- Campus entries do not include direct pedestrian access.

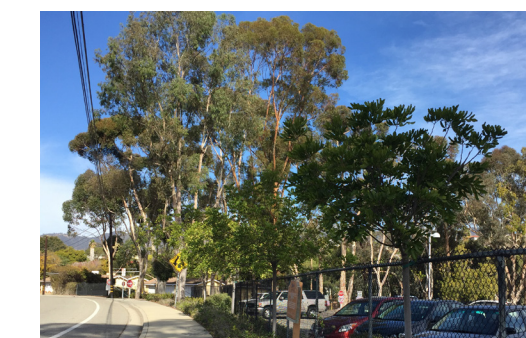
sidewalk along North Turnpike Road

- The campus is separated from the adjacent sidewalk and street by a chain link fence.

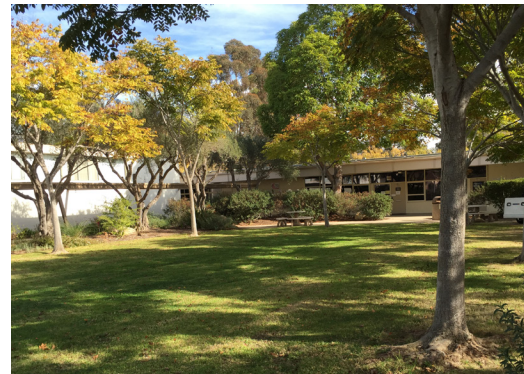
central courtyard adjacent to the main building

- Trees and other accent planting shade the edges of the courtyard, creating a successful gathering space that is well-maintained.

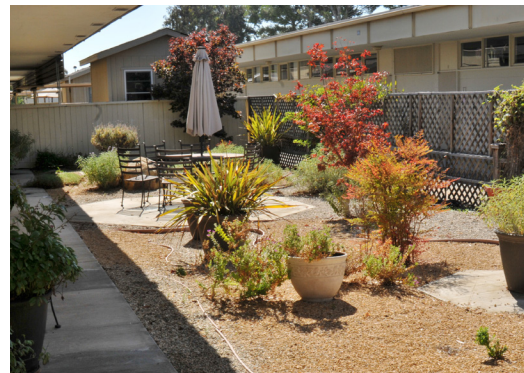
smaller courtyard adjacent to the main building

- This small courtyard is completely enclosed and not visible from the parking lot or other surrounding spaces.

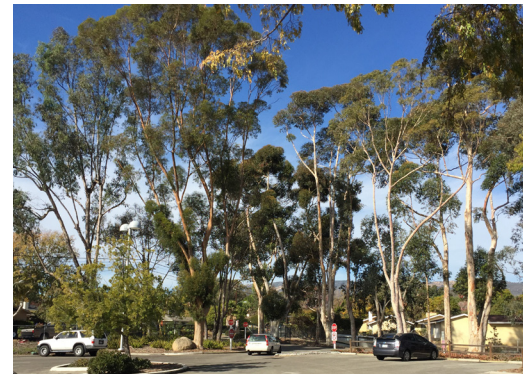
Eucalyptus along campus perimeter

- Stands of Eucalyptus are a dominant landscape feature and create a strong buffer to surrounding residential area.

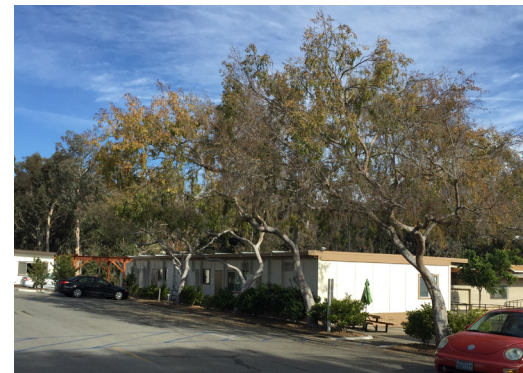
parking lot planting

- Trees in the core of campus are typically small and appear somewhat unhealthy.

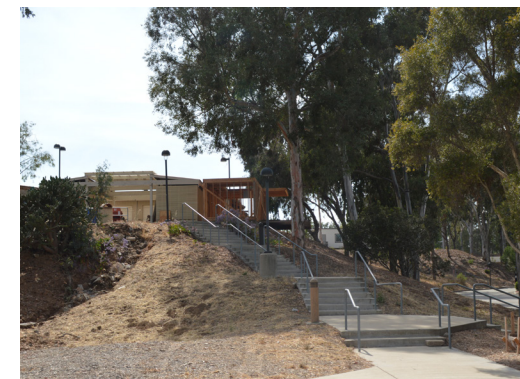
significant grade change sloping down to parking lot

- Large Eucalyptus occupy most of these sloping areas.

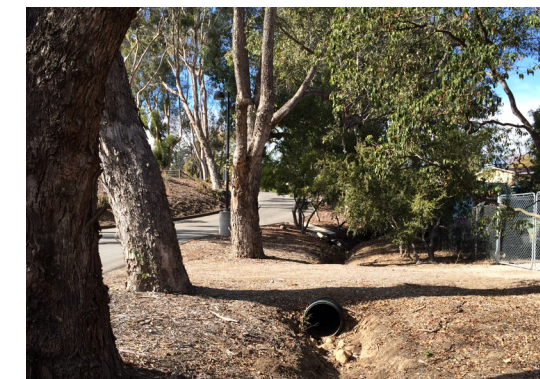
drainage ditch along northern edge of campus

- Drainage ditches line the northern and eastern edges of the site.

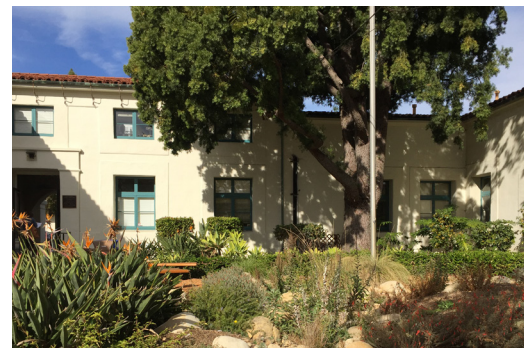
bioretention area

- The bioretention area was designed and built to handle stormwater, however, it is not an engineered installation.
- This installation is an aesthetic evolution of the historic quality of the landscape.

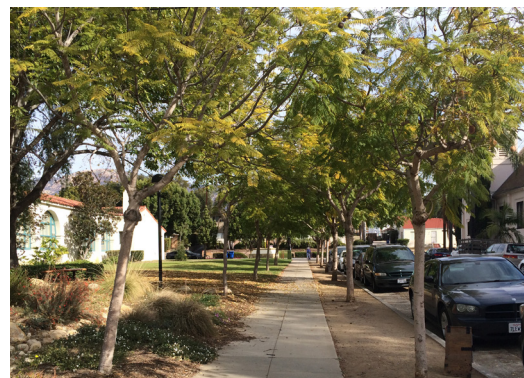
streetscape with street tree allee

- The surrounding streetscapes include an allee of Jacaranda trees lining the sidewalk along Padre Street.
- The curbside planting strip is mostly dirt.

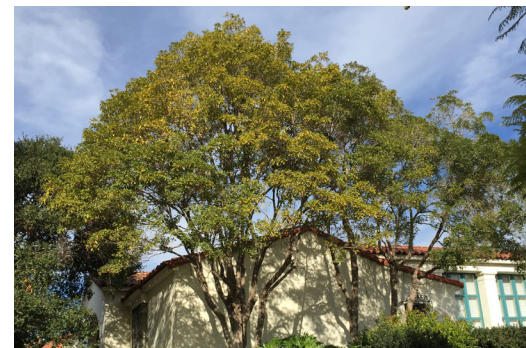
specimen trees and accent planting

- Planting beds filled with specimen trees, shrubs, and groundcover line the southern and eastern facades of the main building.

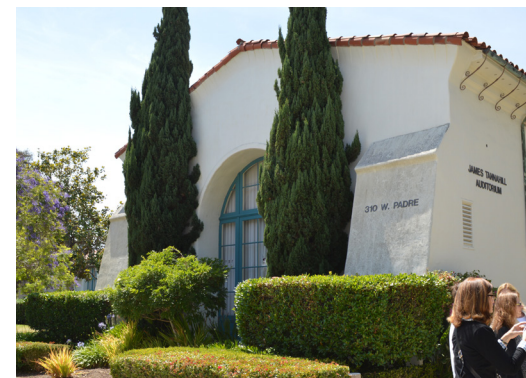
period accent planting

- Classic Spanish Mediterranean planting frames the auditorium entrance and corresponds to the building's historic quality.

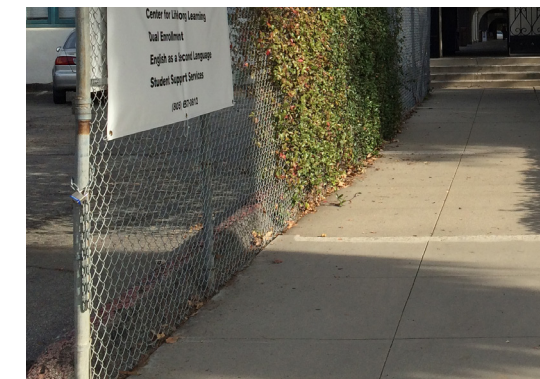
concrete entry

- Walkways connecting building entries to the surrounding sidewalk have uplifting at joints.
- Most of these have been ground down.

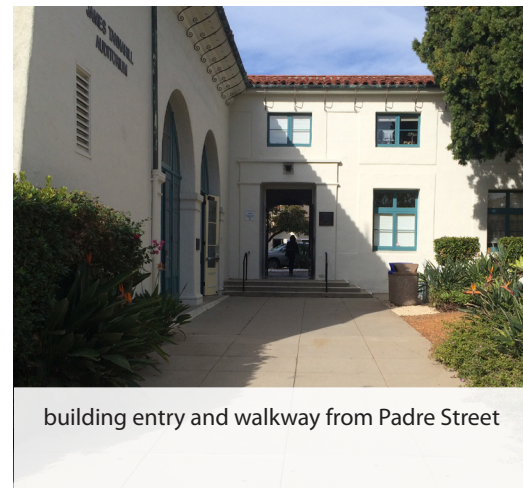
building entry and walkway from Padre Street

- The main entry from Padre Street is only accessible by stairs.

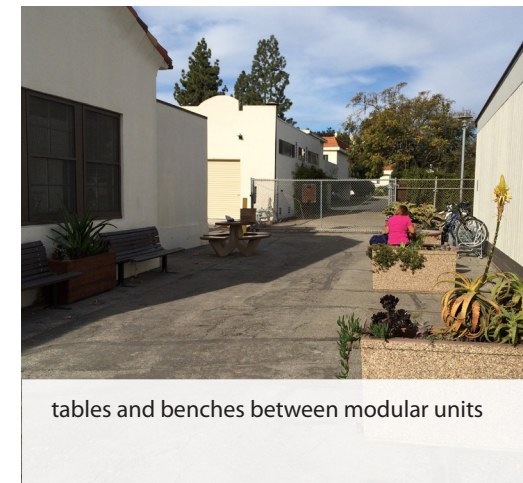
tables and benches between modular units

- Outdoor seating appears arbitrary and unplanned.
- Connectivity between the the historic building and modular units is poor.

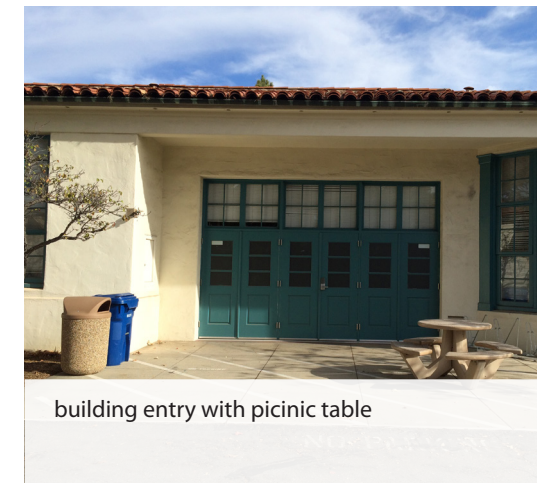
building entry with picnic table

- The picnic table by this doorway is one of the few areas with outdoor seating.

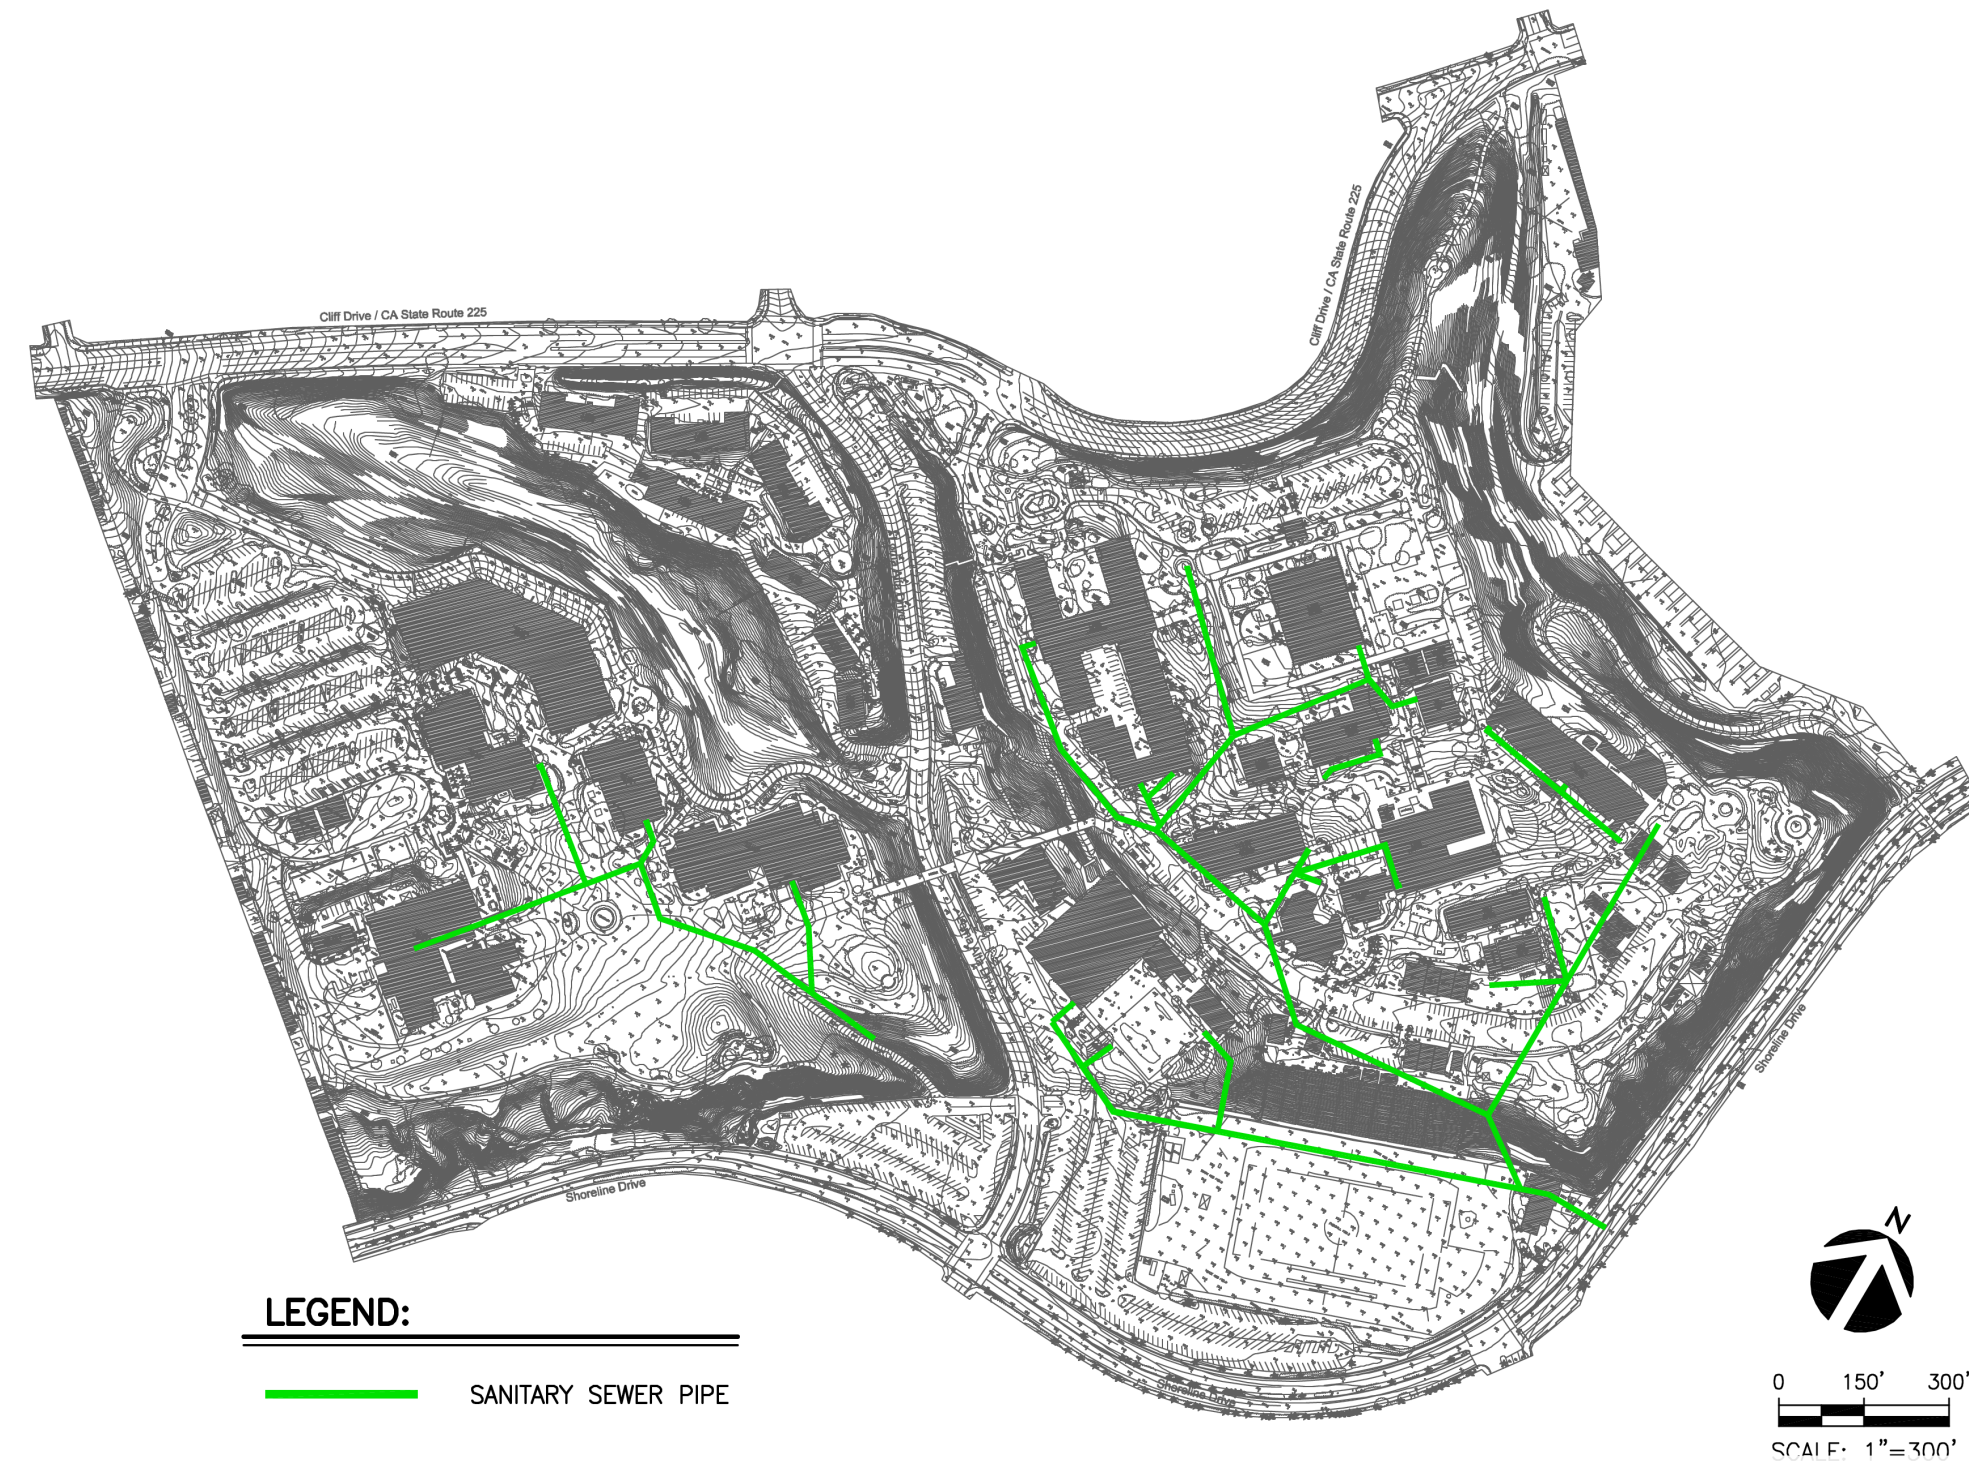
Figure 3.1.11 Existing Sanitary Sewer System

It is our understanding that the campus sewer system is aged and constructed mostly of clay pipes, which have a tendency to deteriorate over time. Additionally, the campus has experienced blockages caused by tree roots damaging, displacing, and/or clogging the pipes. Lastly, a few incidents of vandalism have required repairs to building sewer systems.

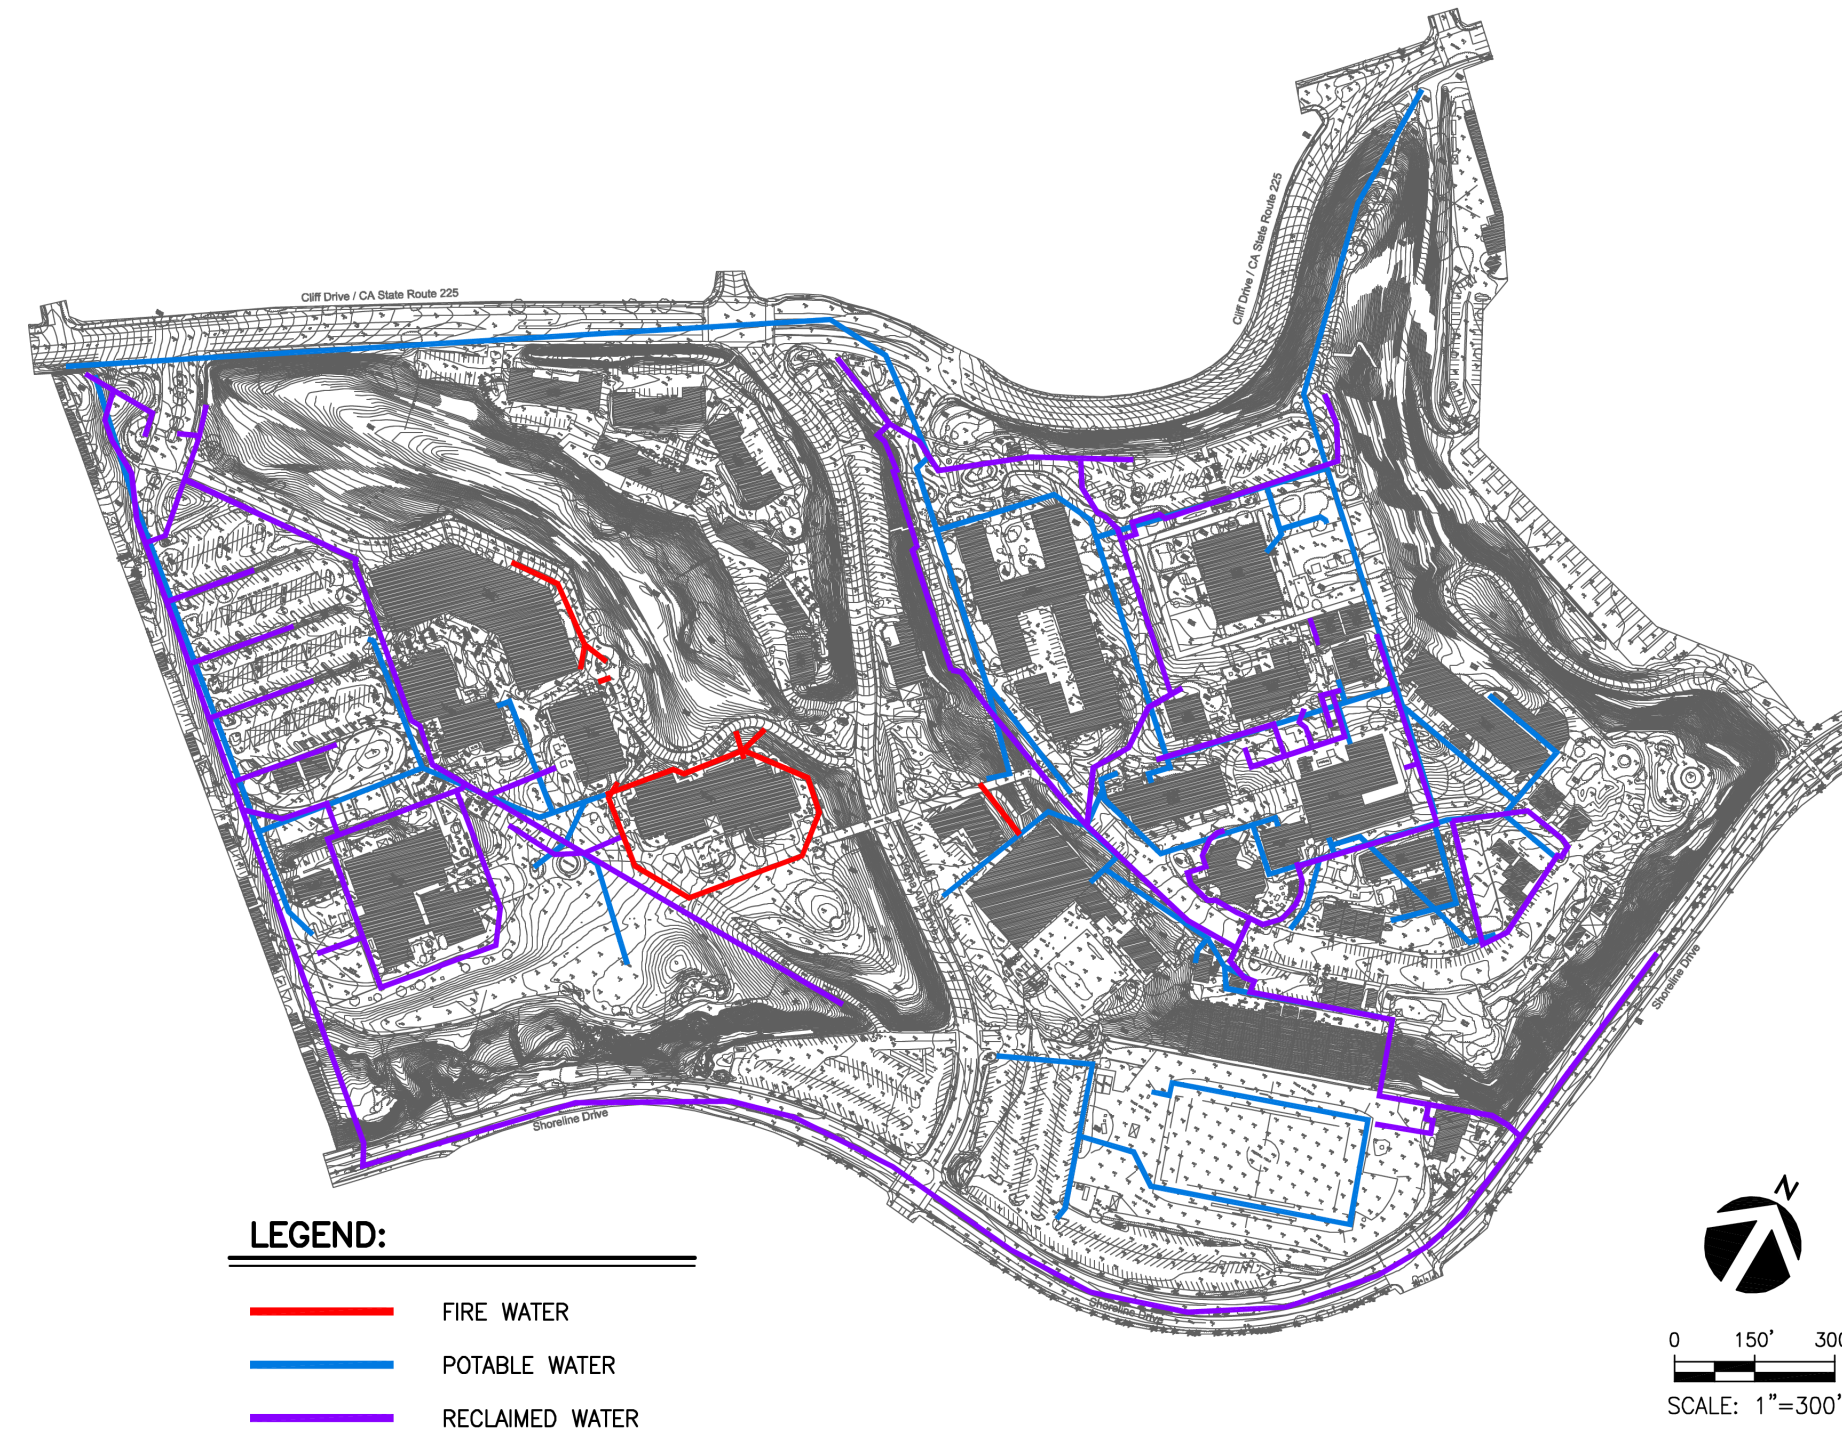
Figure 3.1.11 Existing Water System

It is our understanding that the existing water system is aged and that leaks are common on campus. Additionally, many of the pipes are highly corroded which has required repairs at multiple buildings.

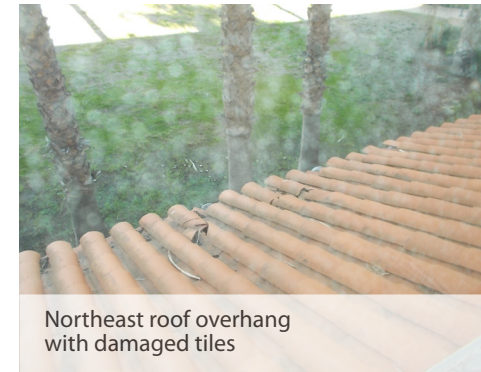
sheet with areas of built up roofing over wood decking. There are various locations where the Spanish tile is broken and damaged.

Northeast roof overhang with damaged tiles

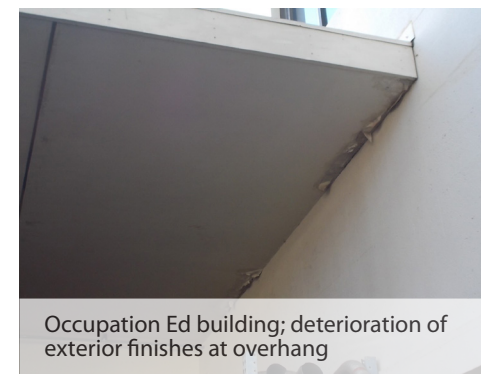
Occupation Ed building; deterioration of exterior finishes at overhang

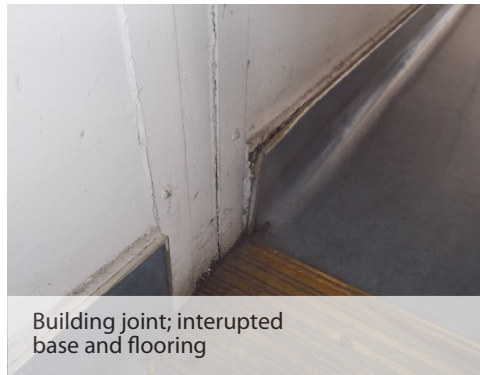
Building joint; interrupted base and flooring

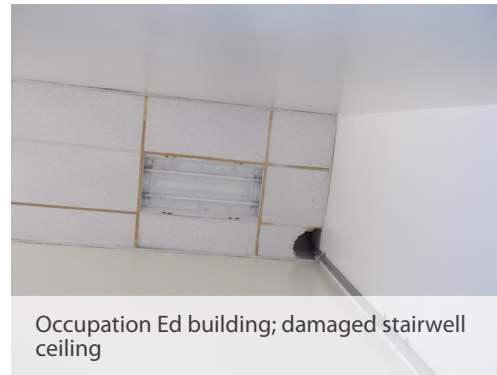
Occupation Ed building; damaged stairwell ceiling

INTERIOR FINISHES: Although some wall and floor finishes have been refurbished during various renovation projects, numerous walls, wall corners and floor finishes throughout the buildings are damaged, outdated, and are in general need of repair.

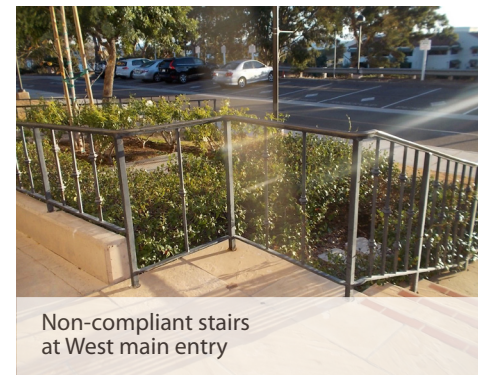
Non-compliant stairs at West main entry

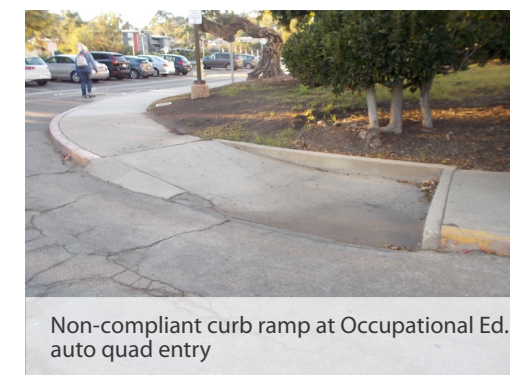
Non-compliant curb ramp at Occupational Ed. auto quad entry

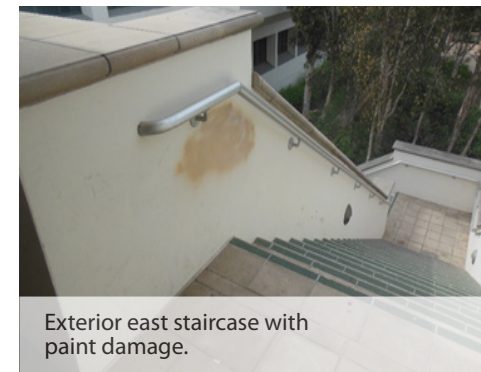
- The exterior wall finish is painted plaster over both concrete and steel stud construction, and at numerous locations, is in very poor condition. The finish is bubbled, peeling, has below surface plaster deterioration, and is in need of repair.

Exterior east staircase with paint damage.

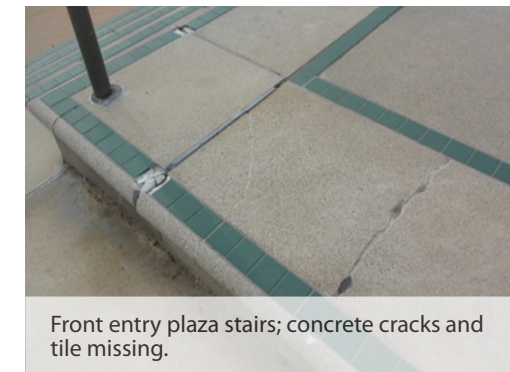
Front entry plaza stairs; concrete cracks and tile missing.

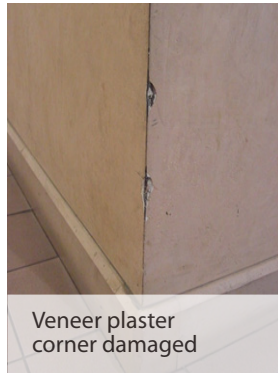
Veneer plaster corner damaged

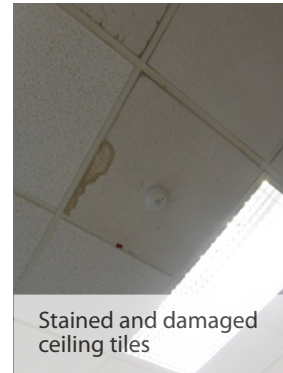
Stained and damaged ceiling tiles

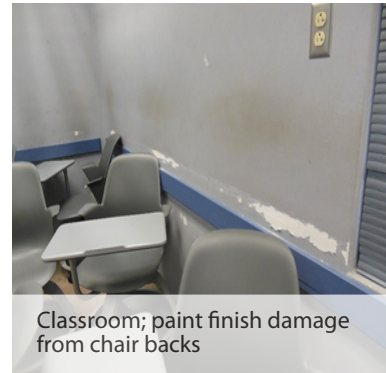
Classroom; paint finish damage from chair backs

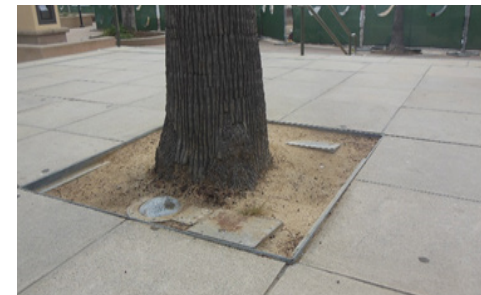
West entry plaza tree well; hazardous surface feature along path of travel.

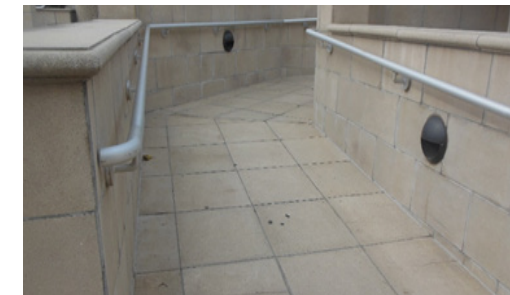
Ramp to building entry; intermediate landing exceeds 2% allowed maximum cross slope

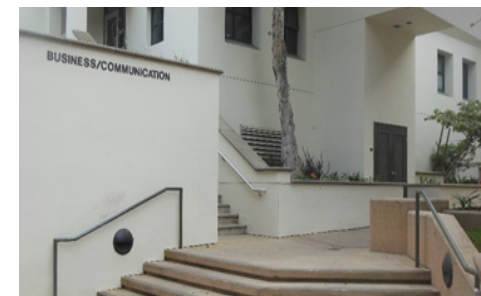
Non-accessible entry lacks wayfinding signs directing user to ramped entry location

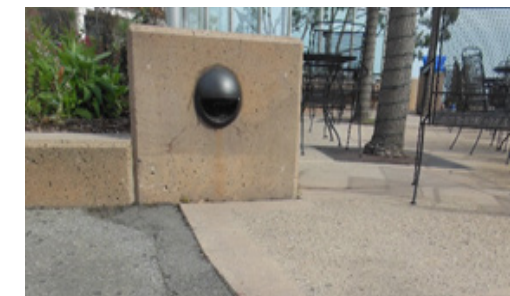
Pathway material transition; abrupt change in level and hazardous surface features

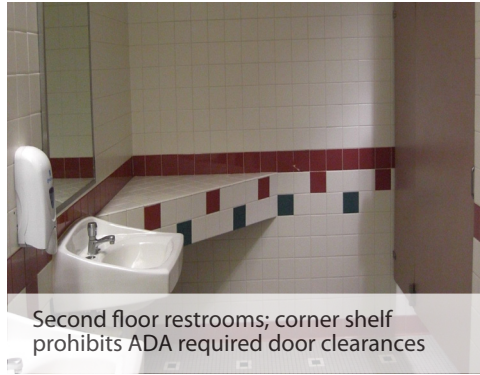
Second floor restrooms; corner shelf prohibits ADA required door clearances

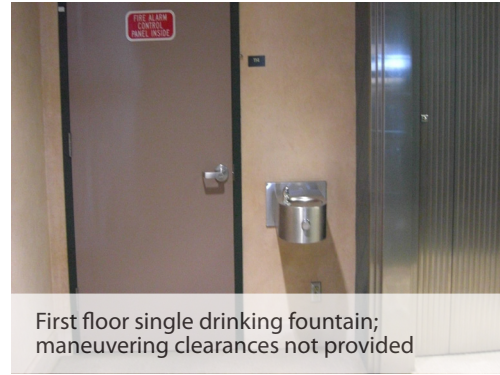
First floor single drinking fountain; maneuvering clearances not provided

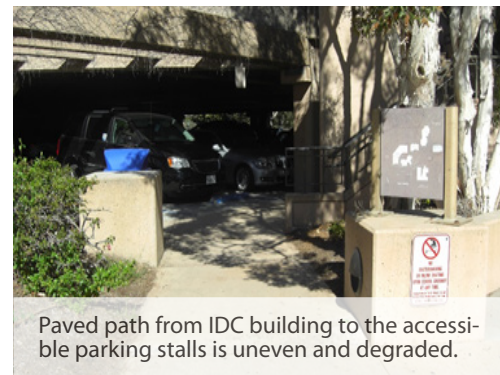
Paved path from IDC building to the accessible parking stalls is uneven and degraded.

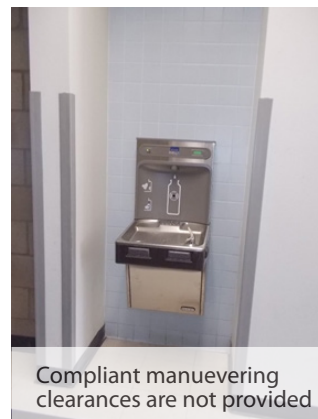
Compliant maneuvering clearances are not provided

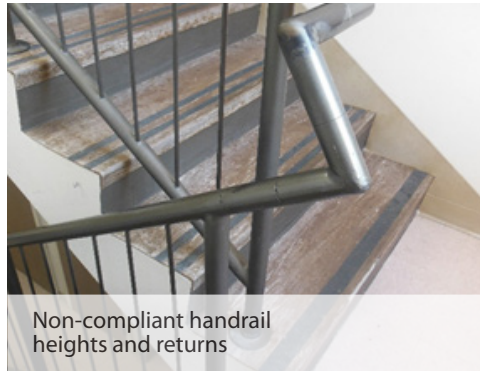
Non-compliant handrail heights and returns

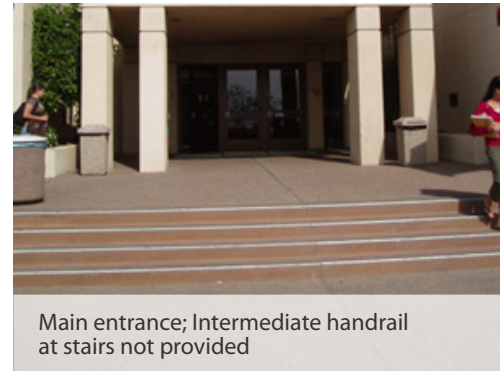
Main entrance; Intermediate handrail at stairs not provided

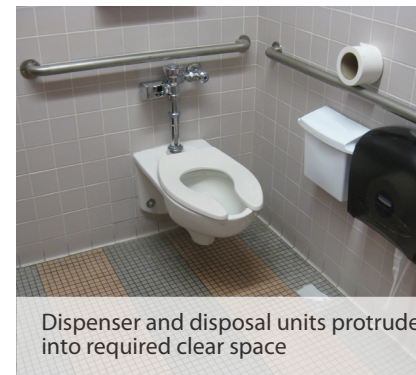
Dispenser and disposal units protrude into required clear space

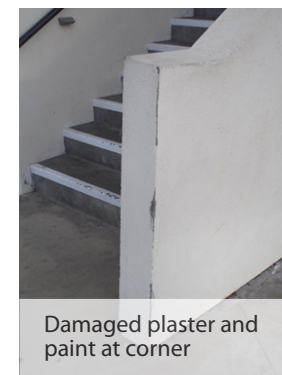
- The exterior painted plaster wall finish is in overall fair condition, with various locations of peeling paint and hairline cracks that require repair and repainting.

Damaged plaster and paint at corner

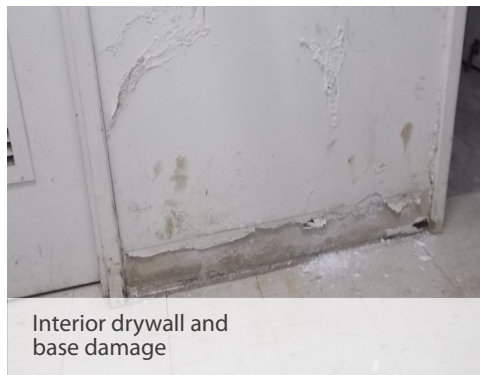
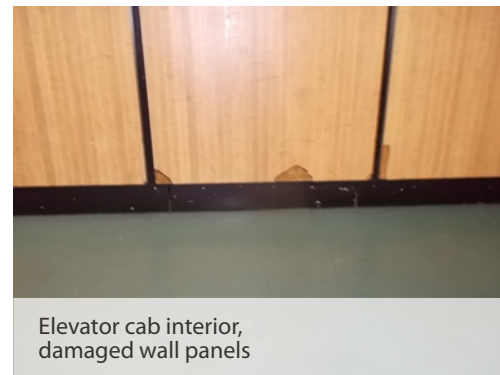
- The finish materials are damaged and stained, and require repainting or refurbishing. The fabric wall covering wainscot is stained, damaged, dirty, and should be replaced with a more durable material.
- A portion of the suspended ceiling system is original and in fair to poor condition. Many suspended ceiling tiles are stained, damaged, require replacement, and at various locations grid members are bent and require refurbishment. The grid finish is discolored, adding to the aging appearance. Additionally, the suspended ceiling system components likely no longer meet current ASTM ratings, the CBC, nor Department of the State Architect (DSA) requirements.

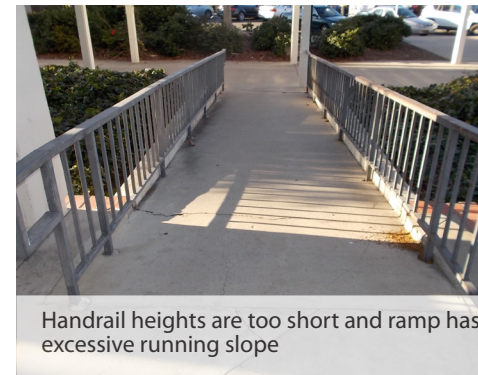
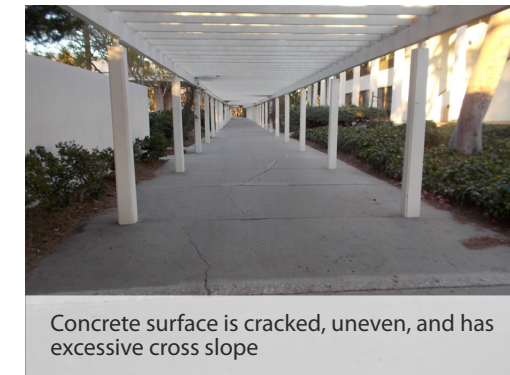
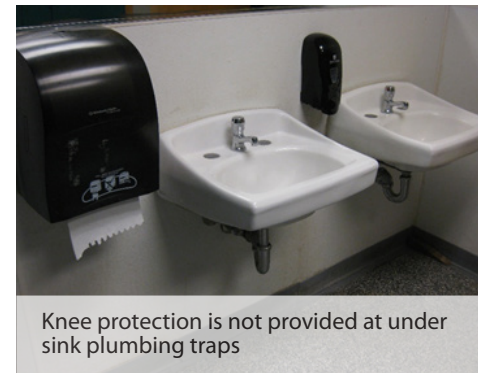
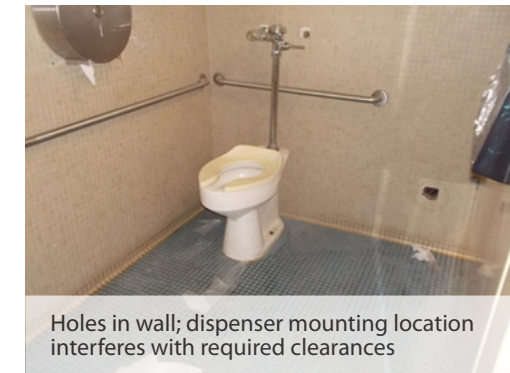
- The concrete walkways around the building, which are intended to be the accessible path of travel, are very uneven, cracked, have abrupt changes in level, expel the user into the fire lane, have excessive cross and longitudinal slopes, and lead to excessively steep sidewalks.

- The path of travel from the adjacent public transportation bus stop on Cliff Drive to the Student Services building is not ADA compliant. There are excessive cross and longitudinal slopes, multiple abrupt changes in level and/or hazardous surface features, non-compliant curb ramps, and no level landing at the sidewalk location to

- The intended accessible path of travel to the building from the accessible parking stalls in Lot 1A is not clearly marked, curb ramps have non-compliant slopes and are missing truncated domes at the vehicular influences, and the concrete pathways are uneven and have tripping hazards.

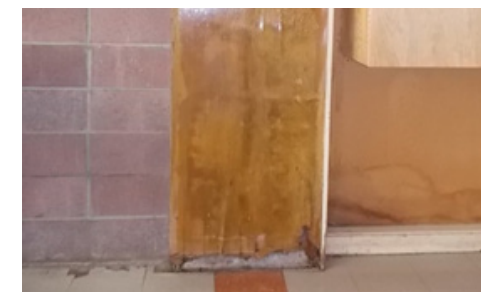
Auditorium walls; water damaged exposed CMU and wood finishes

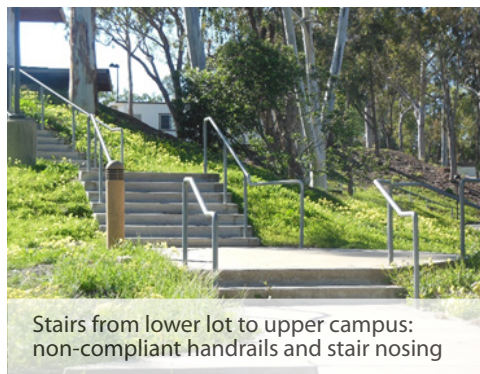
Stairs from lower lot to upper campus: non-compliant handrails and stair nosing

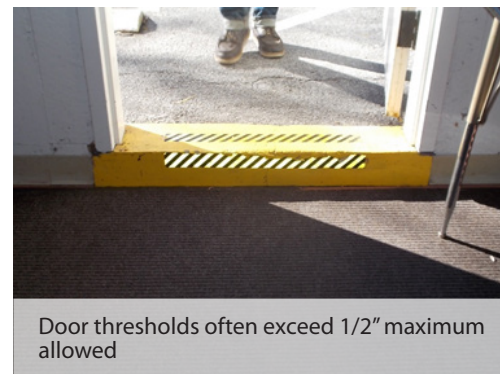
Door thresholds often exceed 1/2" maximum allowed

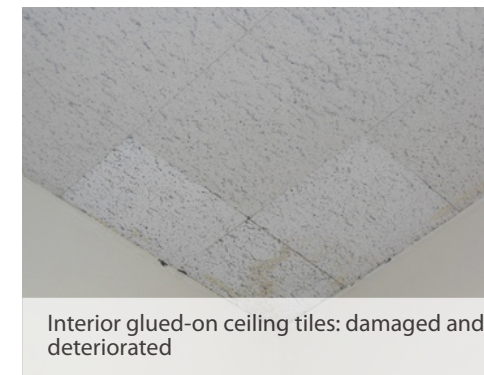
Interior glued-on ceiling tiles: damaged and deteriorated

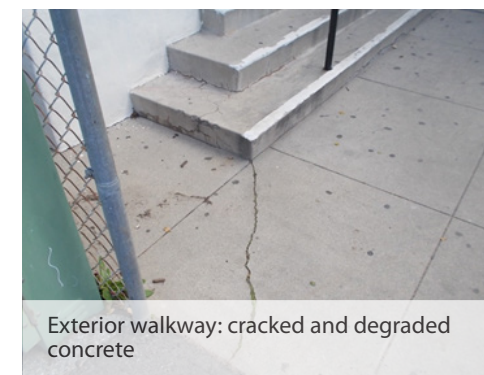
- The exterior plaster paint is in fair condition and, at times, does not correctly match the adjacent surface color.
- The exterior concrete walkways are in poor condition, with deep cracks and uneven surfaces and deteriorated materials

Exterior walkway: cracked and degraded concrete

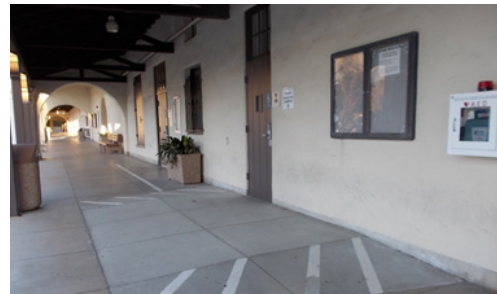
Path of travel interrupted by ramp
